NISSAN DIESEL AMERICA, INC.

BODY BUILDER'S BOOK BULLETIN

DATE: SEPTEMBER 20, 2004
MODEL YEAR: 1999 AND AFTER
CHASSIS MODEL: UD1200/UD1300/UD1400/UD1800CS
BULLETIN NUMBER: BBB-4 (REV.) REPLACES BULLETIN DATED DECEMBER 11, 2001

PRECAUTIONS WHEN INSTALLING PTOs ON AISIN AUTOMATIC TRANSMISSIONS

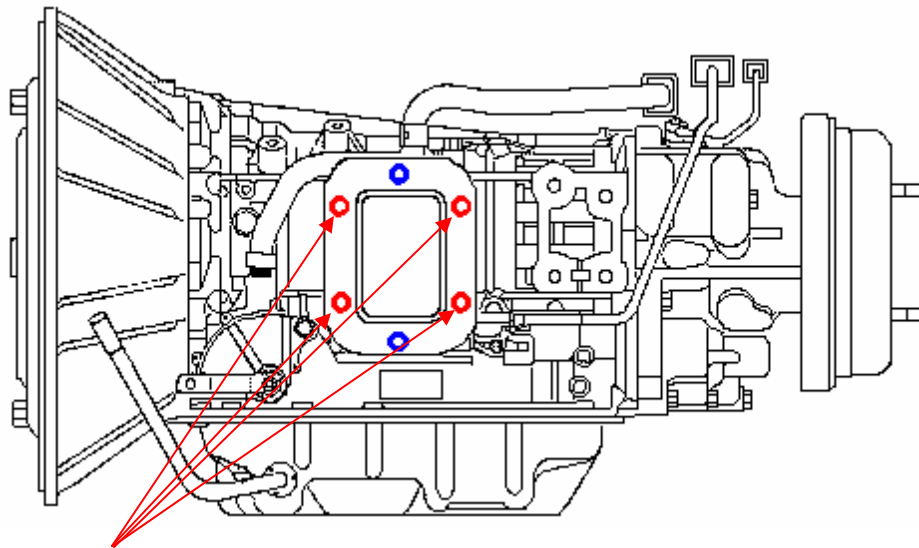
The Aisin automatic transmission has four (4) PTO mounting bolt holes that are drilled through the case. Installation of an incorrect length PTO mounting bolt or stud may result in contact with the transmission internal parts and result in subsequent failure or shortened transmission life.

THESE FOUR (4) BOLT HOLES ARE DRILLED THROUGH. DO NOT INSTALL THE THREADED PORTION OF A PTO MOUNTING STUD OR BOLT IN EXCESS OF A DEPTH OF 15mm OR INTERNAL DAMAGE MAY OCCUR.

Do not install a PTO mounting bolt or stud into the thread hole in excess of a depth of 15mm. Please select the proper length bolt or stud from the installation kit supplied by the PTO manufacturer. Direct all questions to the PTO manufacturer or the NDA Service Operations Department.
