RECALL BULLETIN 08V-617

DATE: January 5, 2009
 MODEL YEAR: 2008
 CHASSIS MODEL: UD1800HD, UD2000, UD2300, UD2600, UD3300
 BULLETIN NUMBER: 08V-617

VOLUNTARY SAFETY RECALL CAMPAIGN NUMBER 08V-617 FUEL PUMP DRIVE COUPLER REPLACEMENT

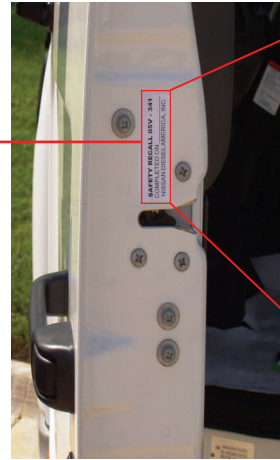
Figure A

- If the involved vehicle has a label on the inside of the driver's door as shown in Figure A, the recall has already been performed and no further action is required.

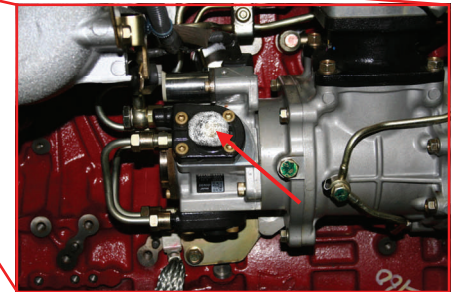
- Inspect the fuel supply pump for a white paint dot as shown in Figure B. If present, the recall has been performed and no further action is required.

- J) Paint a “white” dot on the fuel supply pump. (Reference photo in Figure B on page 3 of 5)

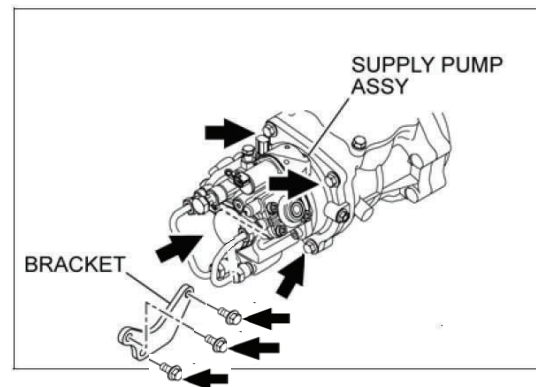
The fuel pump drive coupler installed between the fuel pump and the engine air compressor on the above subject vehicles may experience a failure as a result of improper machining. The improperly machined fuel pump drive coupler could crack without warning under normal vehicle operation. Continued operation with a cracked drive coupler could result in the coupler becoming broken and causing the engine to stall and not restart.

- D) Remove the three (3) bolts on the front bracket of the supply pump and the four (4) bolts securing the supply pump to the air compressor. Remove supply pump and discard drive coupler and o-ring.
