RECALL BULLETIN A5050

DATE: APRIL 23, 2007
 MODEL YEAR: 2005 thru early production 2007
 ENGINE MODEL: J05 & J08
 CHASSIS MODEL: ALL
 BULLETIN NUMBER: A5050

VOLUNTARY EMISSION RECALL CAMPAIGN NUMBER A5050 TURBOCHARGER INSPECTION/REPLACEMENT

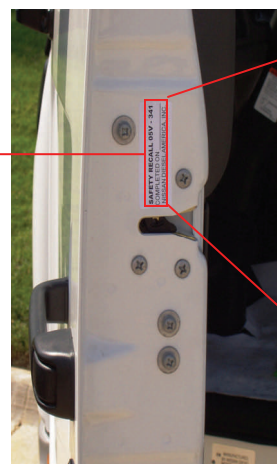
Figure A

- If the involved vehicle has a label on the inside of the driver's door as shown in Figure A, the recall has already been performed and no further action is required.
- If the involved vehicle does not have the label on the inside of the driver's door, verify through the Vehicle Service Notification screen of the NDAINET system that the recall is required. Complete the safety recall according to the following instructions.
