TECHNICAL BULLETIN

DATE: JULY 8, 1993
MODEL YEAR: 1989 AND AFTER
TRANSMISSION: MLS61 (A) & (B)
BULLETIN #: TR - 05

MLS61A AND MLS61B TRANSMISSION REPAIR PROCEDURES

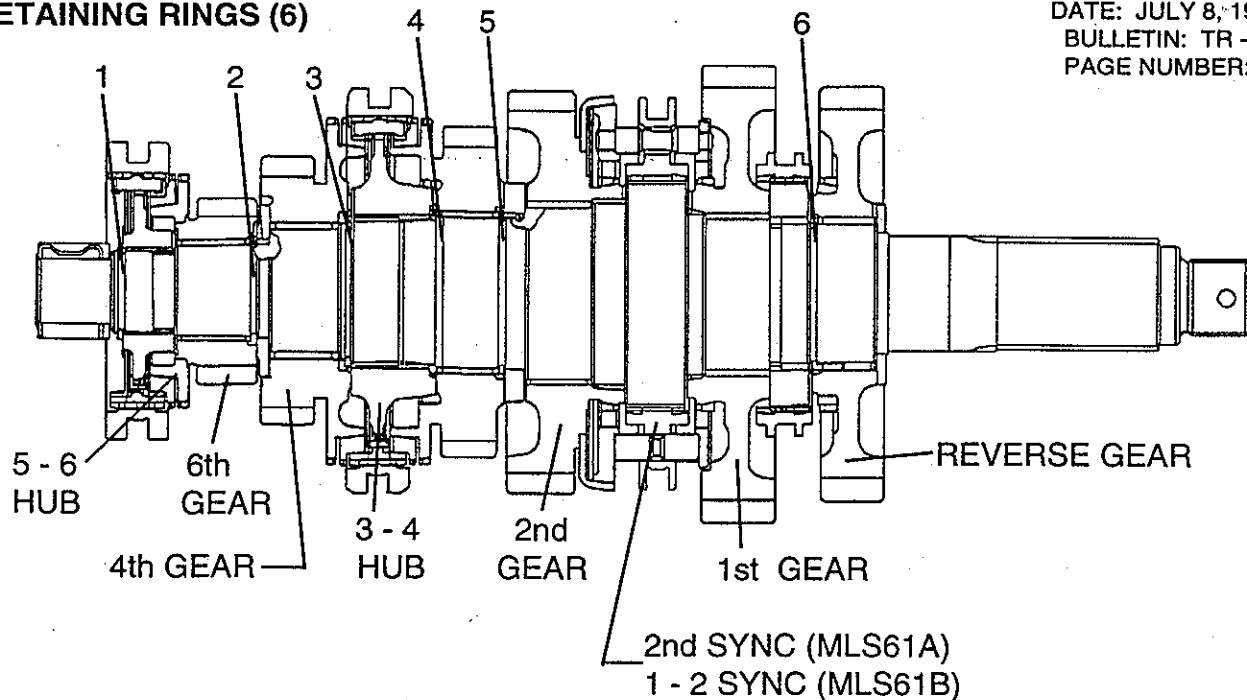
**FIGURE 1**

The MLS61A and MLS61B transmissions are designed with selective retaining rings in the mainshaft which are available in three thicknesses. The purpose for different thicknesses is to re-establish proper clearance in the mainshaft gears with the use of a thicker retaining ring and therefore reduce the cost of the repair. Only retaining ring #4, shown in Figure 1, is not available in three different thicknesses.

There are a total of six (6) retaining rings in the mainshaft of both the MLS61A and the MLS61B transmissions, but only five (5) grooves for the retaining rings. See Figure 1 for the location of the six (6) retaining rings.

Retaining ring #4, for which there is no groove in the mainshaft, is located between 3rd gear and 3 - 4 synchronizer hub. The purpose of retaining ring #4 is to maintain the 3rd gear needle bearing in position and prevent the bearing from "riding up" or travelling on the mainshaft beneath 3rd gear. When properly installed, retaining ring #4 acts as a spacer between 3rd gear and the 3 - 4 synchronizer hub.

The only available thickness for retaining ring #4 is 2.80mm (0.1102"). No other thickness should be installed in place of the correct retaining ring.

Failure to install retaining ring #4 will lead to 3rd gear bearing failure.

Also refer to Parts Bulletin UD93 - 018 dated March 29, 1993 for additional information on locating retaining ring #4 in the Parts Catalog.

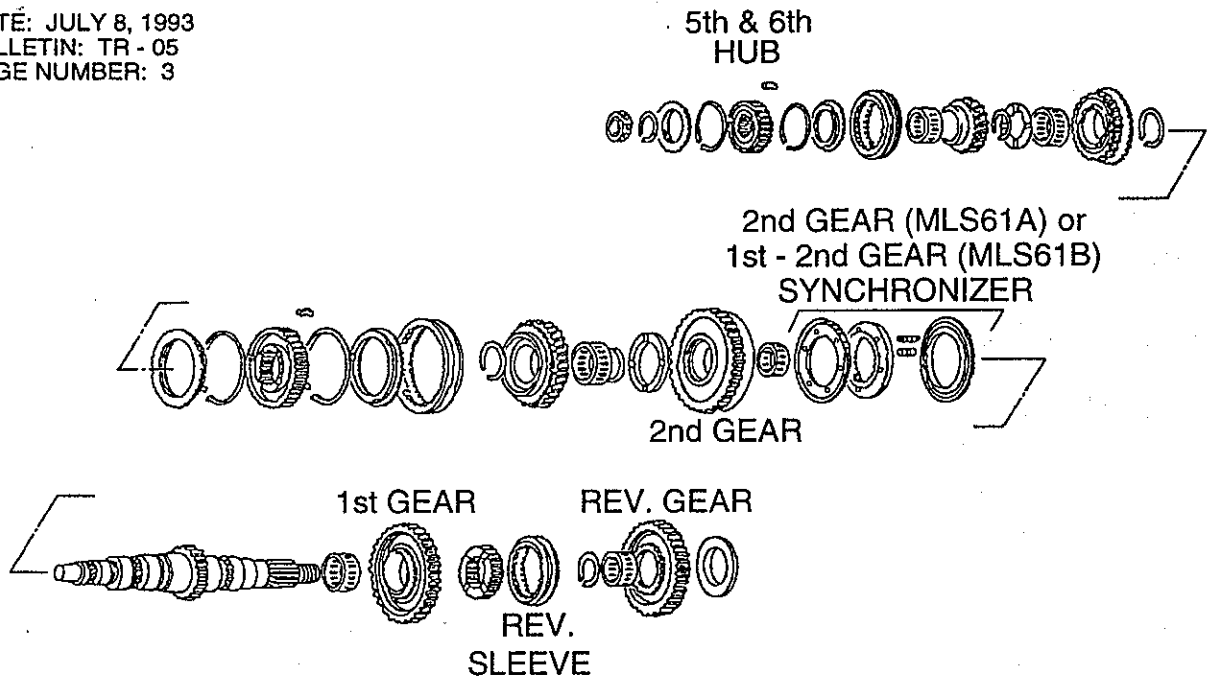
FIGURE 2

In both models, the pin type synchronizer engages 1st and 2nd gears. The reverse sleeve found between 1st and reverse gear in both models engages reverse gear only and has no involvement on 1st gear engagement. See FIGURE 2.

When reassembling either the MLS61A or MLS61B, pay particular attention to the orientation or direction of the components. A simple recommendation for the technician who is not familiar with these, or any other UD Truck transmission, is to mark the components on one side during removal to assure correct reinstallation on the mainshaft.

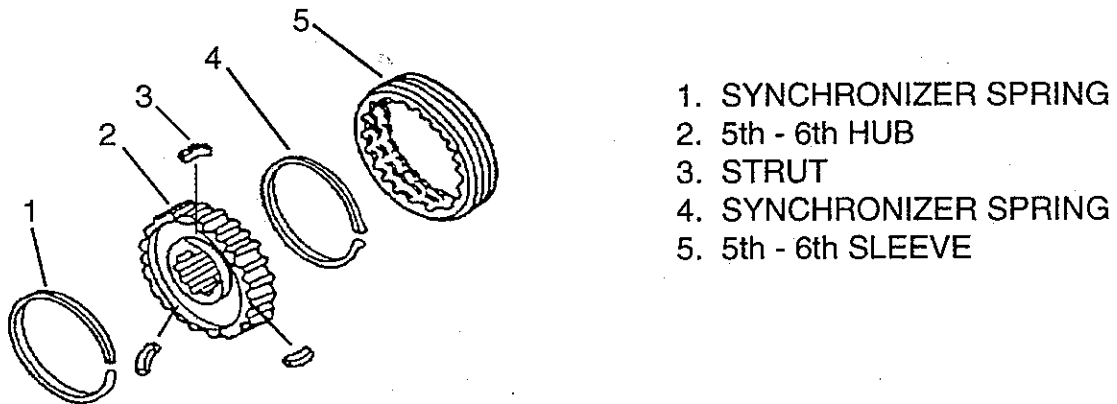
FIGURE 3

The hub of the inertia lock key type synchronizer for the 5th and 6th gear is fitted tightly to the mainshaft splines. Key type synchronizers consist of a hub, sleeve, struts, and synchronizer springs as shown in FIGURE 3.

Another method of installation is to drive the synchronizer components onto the mainshaft splines using a suitable driver. When utilizing this method, it is recommended that the synchronizer not be driven onto the mainshaft as an assembled unit because the struts and springs of the synchronizer may fall out during the driving operation and be overlooked when mainshaft reassembly is completed.

The synchronizer assembly can be pressed on the mainshaft splines as an assembled unit.

Install the bottom synchronizer spring (item #4) on the hub (item #2), drive the hub onto the mainshaft ensuring that the bottom spring is secure, and then assemble the synchronizer assembly after seating the hub on the mainshaft splines.
