RECALL BULLETIN 05V-262 (Rev. A)

DATE: OCTOBER 7, 2005
 MODEL YEAR: 1999 thru Early Production 2002
 CHASSIS MODEL: UD1200/UD1400
 BULLETIN NUMBER: SC-262
FILE IN THE ELECTRICAL SECTION OF THE TECHNICAL BULLETIN BINDER
 (Discard previous Recall Bulletin dated September 12, 2005)

**VOLUNTARY SAFETY RECALL CAMPAIGN NUMBER 05V-262:
 BATTERY CABLE INSPECTION AND/OR REPLACEMENT**

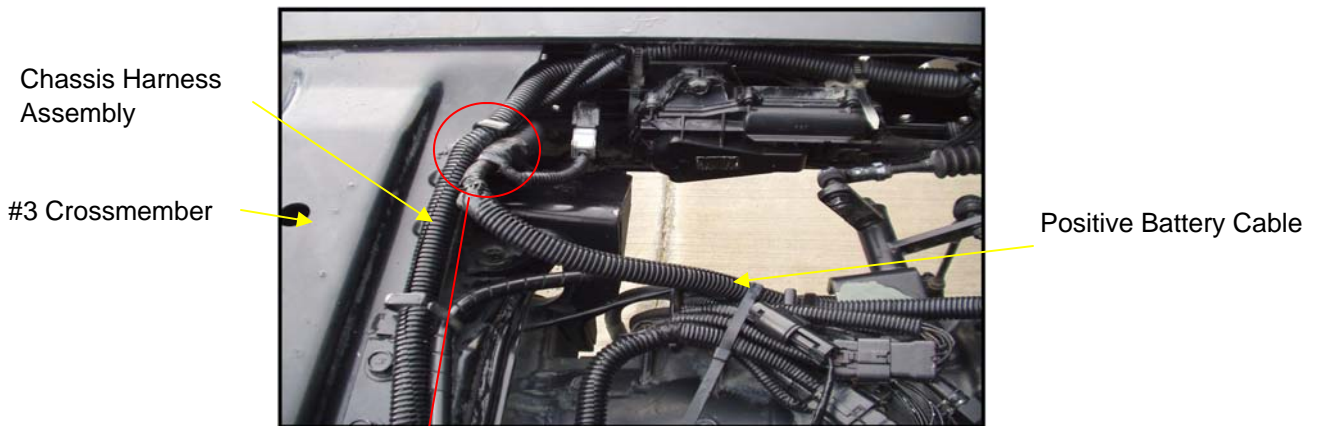
Figure A1 (1999 & 2000 MY)

If the battery cable is not damaged inspect the Positive Battery Cable for proper routing as illustrated in Figure A1 and A2. Re-route the cable correctly as necessary. Proceed to Step 3.

Clamp the battery cable securely with the Chassis Harness to the cross member using the welded harness clip.

NOTE*: If the 3rd frame cross member is missing the welded retaining clip or is broken, use a Tie Strap PN 01552-00043 (from the Safety Recall Parts Kit) to secure the battery cable to the chassis harness as shown in Figure A2.
