TECHNICAL BULLETIN

DATE: OCTOBER 8, 1993
MODEL YEAR: ALL
CHASSIS: UD1100,
UD1300, and UD1400
BULLETIN: CL - 002(REV.)

FD35T AND TD42T ENGINE FLYWHEEL MACHINING ALLOWANCE

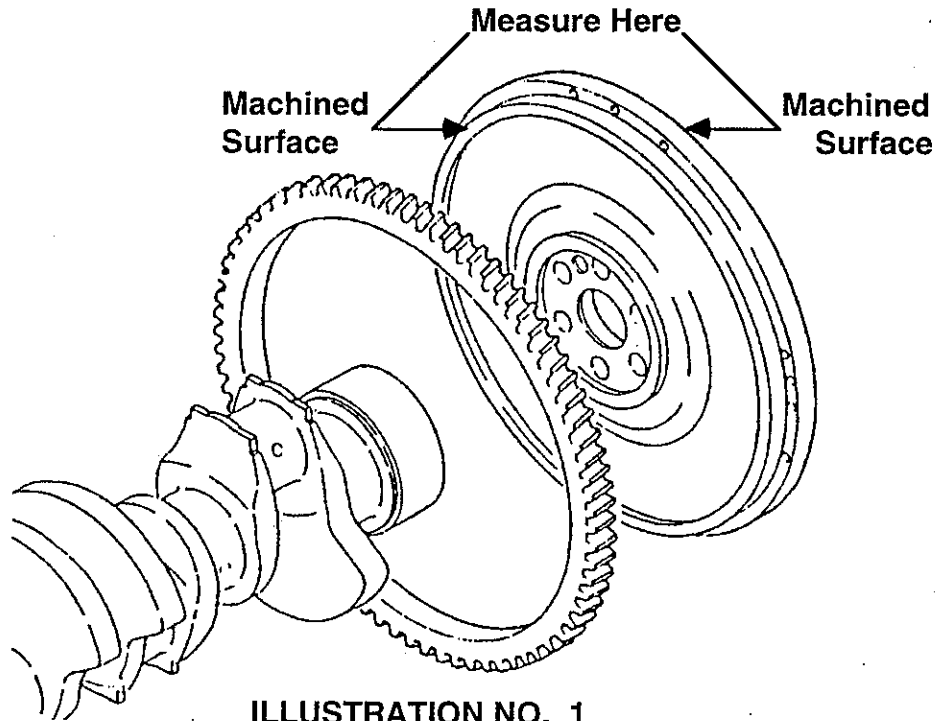
ILLUSTRATION NO. 1

Previous machining operations of the flywheel will determine the amount that the flywheel can be machined and still remain within the minimum flywheel thickness allowed.

Use a 1" - 2" (25 - 50 mm) micrometer to measure the thickness of the flywheel assembly. Measurement for total thickness should be taken between the clutch contact surface area and the machined surface on the backside of the flywheel just below the ring gear. See Illustration No. 1.

Replace the flywheel assembly if more than 0.020" machining is needed. The repairing UD Truck Dealer should also measure the flywheel assembly whenever machining appears to be needed in order to determine if the flywheel has been machined previously.

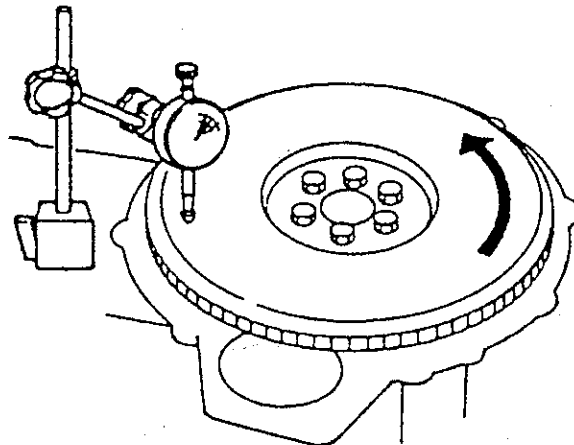
ILLUSTRATION NO. 2

Chassis Model	Total Indicator Runout
UD1100	0.008" (0.2 mm)
UD1300	0.0039" (0.1 mm)
UD1400	0.0039" (0.1 mm)

Replace the flywheel assembly if the runout exceeds the specifications listed in Illustration No. 2. Excessive runout in the flywheel assembly indicates a bent flywheel.
