DATE: JULY 30, 1998
MODEL YEAR: 1995 ~ 1998
CHASSIS MODEL: UD1800 ~ UD3000
ENGINE MODEL: FE6TA
BULLETIN #: GE - 17
FILE IN THE GENERAL SECTION OF THE TECHNICAL BULLETIN BINDER

INJECTION PUMP COUPLER BOLT TORQUE CORRECTION

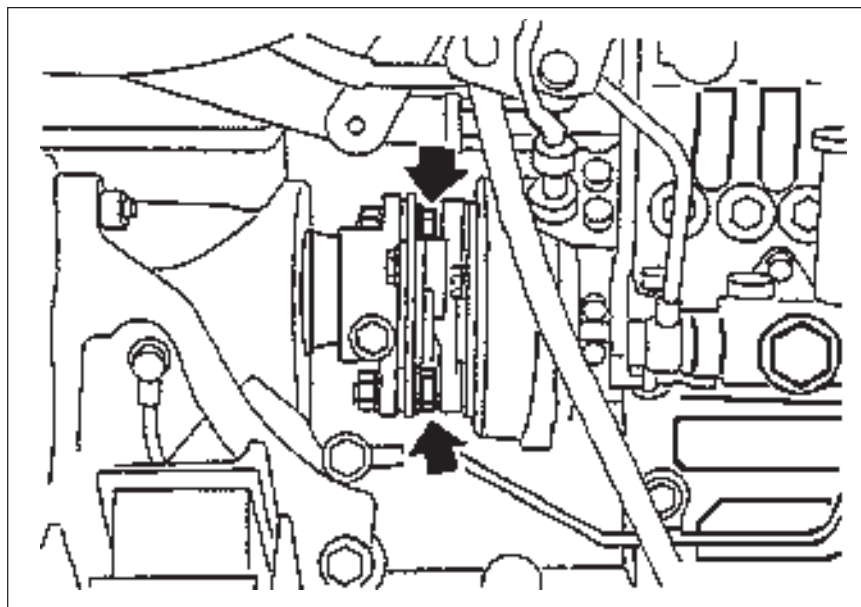
- Page DR-6-9, Step 8, *incorrectly* states the injection pump coupler bolt torque as:
T : 22 ~ 25 ft·lb (29 ~ 34 N·m) (3.0 ~ 3.5 kg·m).

- The *correct torque* for the injection pump coupler bolt, as indicated on page MA-5-10, should be:
T : 43 ~ 47 ft·lb (59 ~ 64 N·m) (6.0 ~ 6.5 kg·m).

Dealers are instructed to make the necessary changes to page DR-6-9, Step 8, to reflect the correct injection pump coupler bolt torque as referenced above.
