Engine Software Update

GH7 ENG 2011, 2012 and 2013 MY UD-MD

FSB 284-035 Engine Software Update

(February 2014)

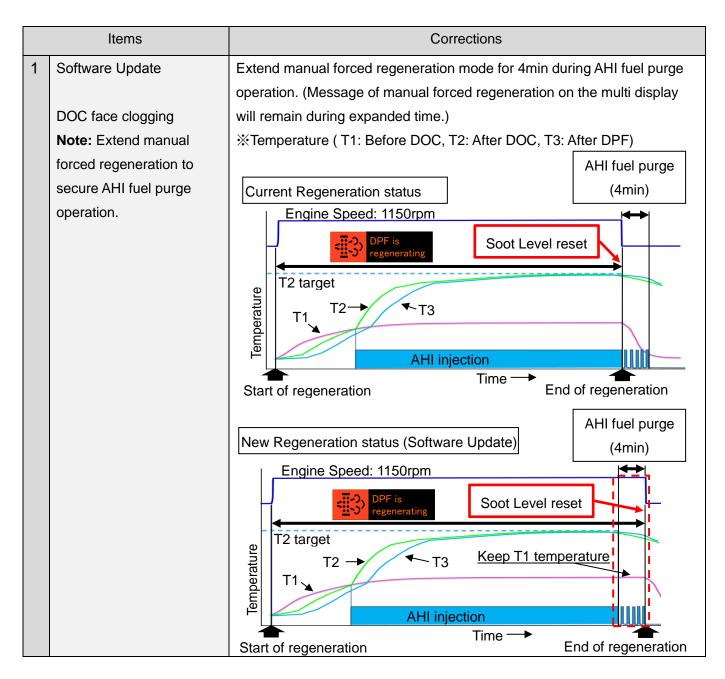
Explanation of Software Update:

- 1. DOC face clogging.
- 2. Injector out of calibration.
- 3. Soot Bar behavior change during manual regeneration.

Items		Correction		
1	DOC face clogging.	Extend manual forced regeneration mode for 4min during AHI fuel purge operation. (detailed explanation on page 2)		
2	Injector out of calibration.	Engine warning lamp lights up and fault code indicate in cluster when this error occurs.		
3	Soot bar behavior change during manual forced regeneration.	Soot bar remain until manual forced regeneration is completed.
