# NISSAN DIESEL AMERICA, INC.

## RECALL BULLETIN 03E-036

### **VOLUNTARY SAFETY RECALL CAMPAIGN NUMBER 03E-036: REPLACEMENT OF THE COOLER HOSES ON THE MALONE OIL COOLER ASSEMBLY**

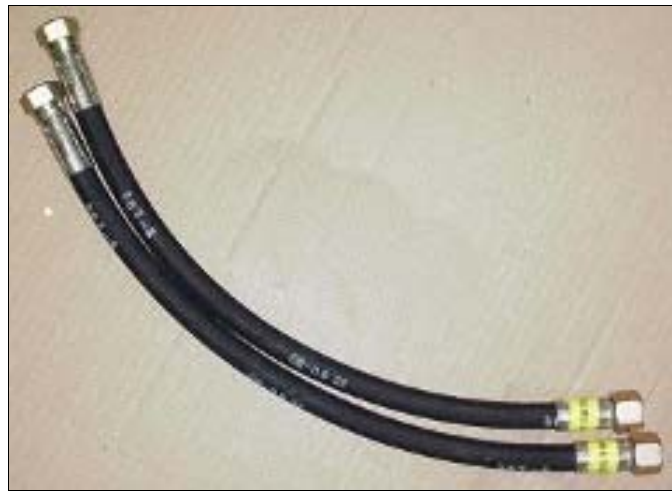
**PART NUMBER MLUDXCHA5**

**MALONE SPECIALTY, INC. AUTOMATIC  
TRANSMISSION COOLER HOSES**

**TWO (2) HOSES REQUIRED PER VEHICLE**
