SERVICE NEWS LETTER 055

SAFETY RECALL 00V - 059 STOP MOTOR INSTALLATION TIPS

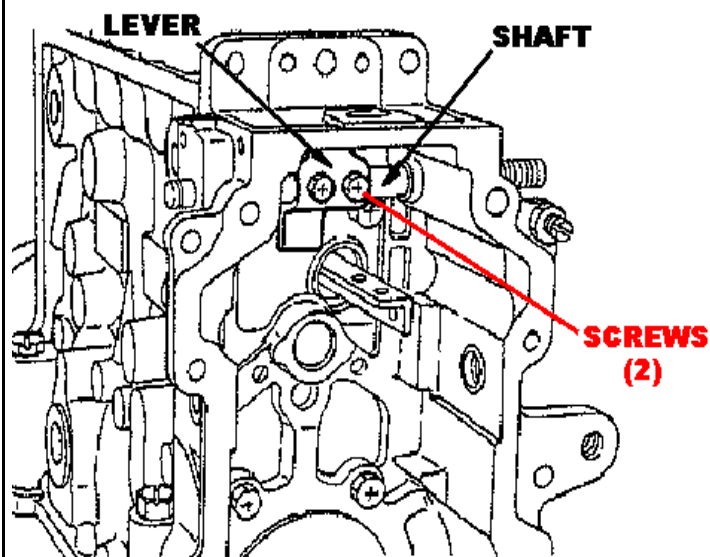
Two screws that attach the internal stop lever to the stop lever shaft sheared and broke off.

Failure to support the stop lever shaft from turning beyond its limits whenever the external stop lever retaining nut was removed or tightened.

When performing Safety Recall 00V - 059 it is very important that the instructions provided on Page 5, item 6b, be followed completely. Allowing the stop lever shaft to over-turn will lead to internal pump breakage.
