SERVICE NEWS LETTER 057

ABS MODULATOR/RELAY CONNECTIONS

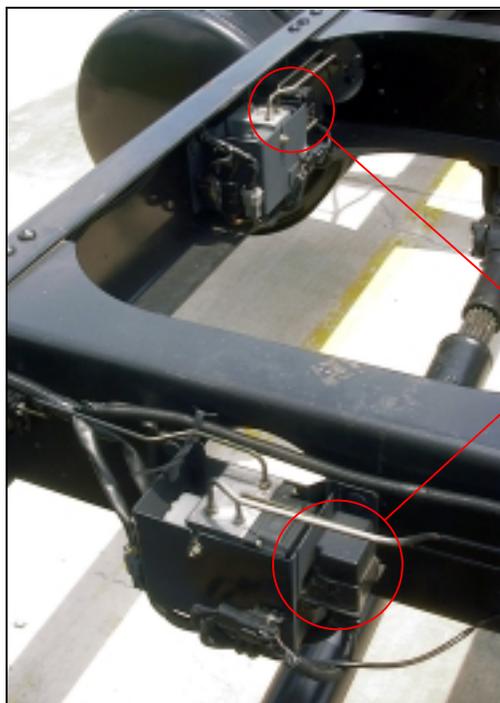
UD2300/UD2600/UD3000

Field investigations have determined that the ABS fault code 6-2 may be due to a faulty electrical connection between the modulator valve and motor relays and connector terminals inside the connector housing that is mounted on the side of the modulator assembly.

If an ABS fault code of 6-2 is received, it is recommended that the technician remove the modulator valve and motor relays and inspect the terminal connections. Failure to inspect the relay connections can result in an incorrect ABS diagnosis and the unnecessary replacement of the modulator assembly.

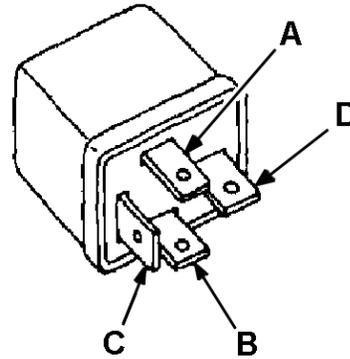
MOTOR RELAY

3. Visually inspect the modulator valve and motor relay terminal contact surfaces for any indication of poor electrical contact or broken terminals.

4. Thoroughly clean the electrical contact surfaces with an aerosol electrical contact cleaner available locally from any electronic or hardware store.

5. Inspect the cleaned electrical terminals for damage. If damage is present, replace the modulator valve and motor relay assembly with Genuine UD Part Number 47670-30Z00.

6. Prior to reinstallation, apply a small amount of dielectric grease between the relay terminals and connector housing using 3M brand part number 051135-08770 or equivalent.
