**DATE:** JANUARY 20, 1998  
**MODEL YEAR:** 1994 & LATER  
**CHASSIS MODEL:** UD1400/1800/2000/2300/2600/3000  
**BULLETIN #:** AC - 04

**RED DOT R134a REFRIGERANT CHARGE SPECIFICATION CHANGE**

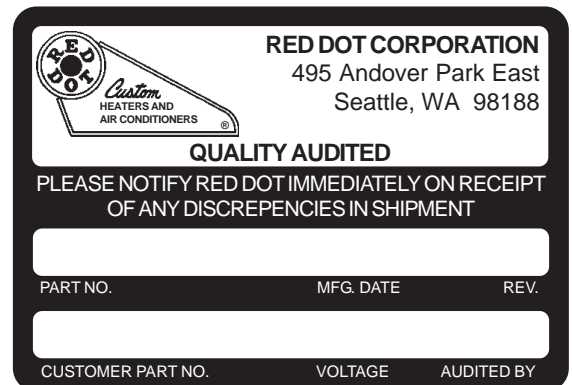
The reduction in condenser coil size also affects the refrigerant charge specification for these models. A/C system installers and service technicians must determine which condenser coil is installed in a vehicle to decide the proper refrigerant charge by reading the "MFG. DATE" on the QUALITY AUDIT label shown below and attached to the condenser assembly housing. The smaller coils were implemented in condenser assemblies manufactured after May 1, 1997 in the R2170 A/C system and after September 22, 1997 in the R2190 A/C system.
