## SUBJECT: Additional Inspection Point for High Soot and Frequent Regenerations

Department: Service  
Section: Engine  
Model(s): GH7  
Model Year(s): 2011, 2012 & 2013  
Effective Date: October 13, 2014  
Form #: TB EN-54  
Rev #: N/A  
Supersedes: N/A

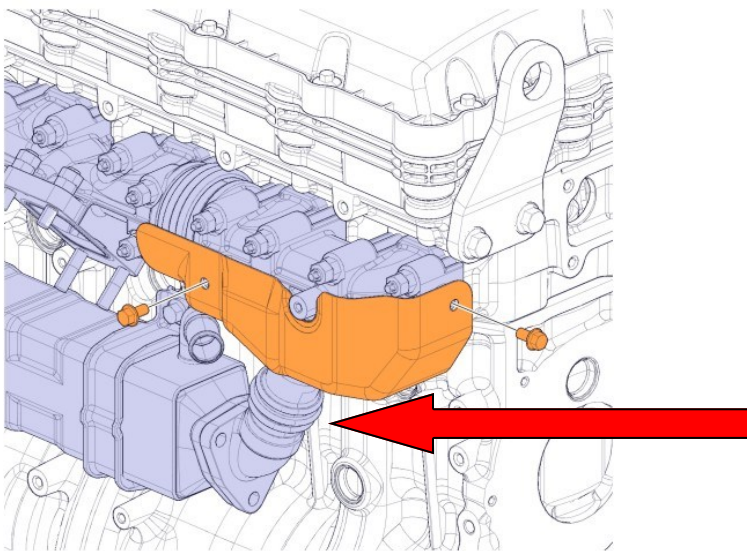
**EGR cooler pipe location**

EGR cooler pipe crack can be the cause for the symptoms mentioned above.

- ◆ If cracks or soot deposit are found replace the pipe.
- ◆ If not found, follow Guided Diagnostic for other suspected root cause.

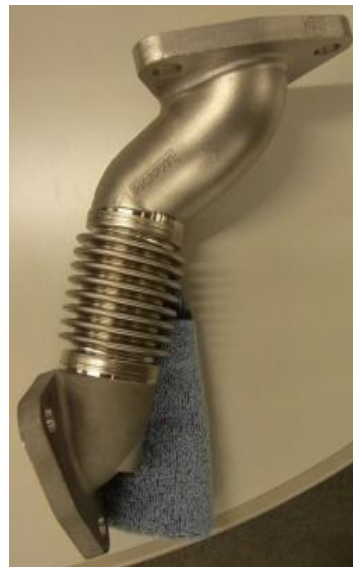
**EGR cooler pipe**

Check if there is soot deposit and cracks on the EGR cooler pipe.
