SUBJECT: Passing Oil Complaints in GH7 Turbochargers

Department: Service
 Section: Engine
 Model(s): GH7
 Model Year(s): 2011, 2012 & 2013
 Effective Date: October 8, 2015
 Form #: TB EN-57
 Rev #:
 Supersedes:

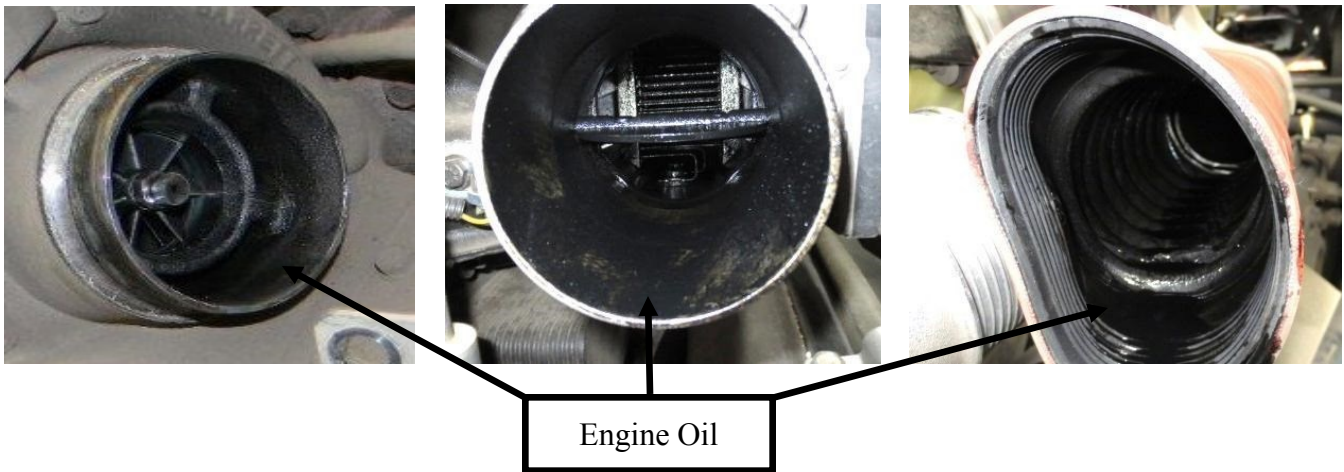
Inspection: Verify oil is NOT coming from the air inlet side of the turbo. Inspect for oil entering the turbo from the CCV or air compressor.

Example in which a lot of oil entered into the intake system from CCV

Condition 1. If a large amount of oil has been entering the intake air system on the inlet side of the turbo the warranty repair procedure is to clean the oil from the parts. See drawing 50 below.

Do not replace the turbo for this condition.
