TECHNICAL BULLETIN TR-23

DATE: JUNE 28, 2006
 MODEL YEAR: 2005 & AFTER
 TRANSMISSION MODEL: AISIN TRANSMISSION
 CHASSIS MODEL: UD1300, UD1400, UD1800CS
 BULLETIN NUMBER: TR-23
FILE IN THE TRANSMISSION SECTION OF THE TECHNICAL BULLETIN BINDER

AISIN ATM ALIGNMENT DOWEL PINS

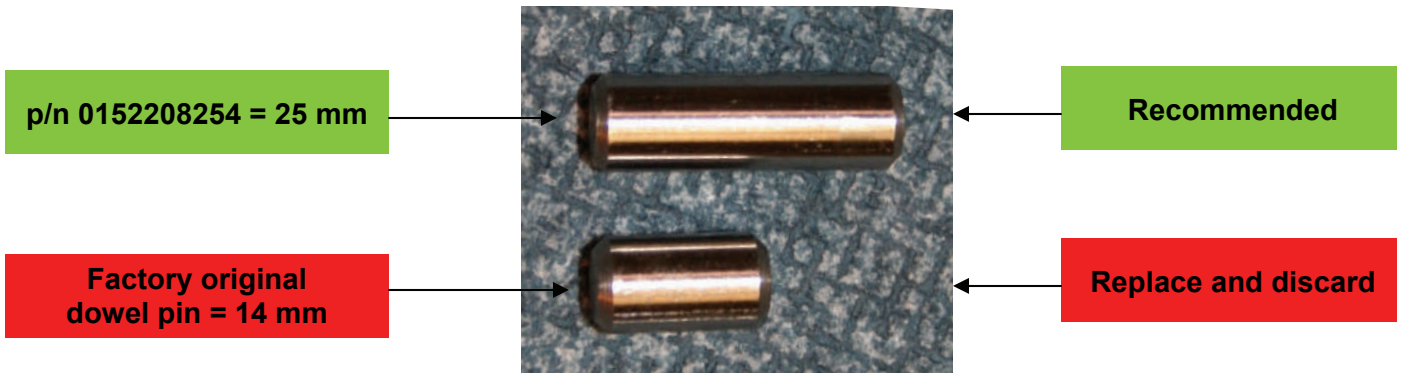
Dowel Pins

To advise UD Truck Dealers that they are required to install longer dowel pins in the UD1800CS engine fly-wheel housing whenever the Aisin transmission is removed. The original factory dowel pins may be pushed into the housing and not protrude for correct transmission to engine alignment.

NOTE: Dowel pin 0152208254 is 25 mm long and provides improved alignment of the transmission to the engine. The factory original dowel pins are 14 mm long and should not be reused. See figure below.

Whenever vehicle repair or service procedures require the removal of the Aisin transmission in the UD1800CS models, the engine flywheel housing dowel pins part number 0152208254 must be installed.

Install dowel pin 0152208254 until it bottoms in the flywheel housing dowel pin hole. Approximately 13 mm will protrude for improved transmission alignment.
