RECALL BULLETIN 09V-487

DATE: March 1, 2010
MODEL YEAR: 2007 & 2008
CHASSIS MODEL: UD3300 with Locally Installed DUAL STEERING
BULLETIN NUMBER: 09V-487

VOLUNTARY SAFETY RECALL CAMPAIGN NUMBER 09V-487
BRAKE APPLICATION / RELEASE TIMING CORRECTION

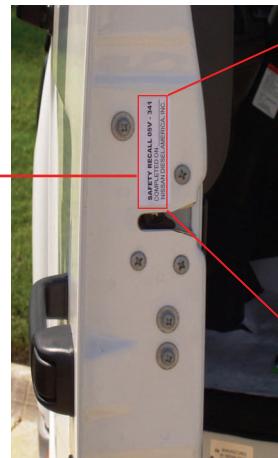
- If the involved vehicle has a label on the inside of the driver's left door as shown in Figure A, the recall has already been performed and no further action is required.
- If the involved vehicle does not have the label on the inside of the driver's door, verify through the Vehicle Service Notification screen of the NDAINET system that the recall is required. Complete the safety recall according to the following instructions.
- Park the vehicle on a flat surface, place the transmission in NEUTRAL, set the parking brake and chock the rear wheels.

Step 21) Record the completion date on the Safety Recall 09V-487 sticker as shown and apply to the driver's left side door as shown in Figure A on page 2.

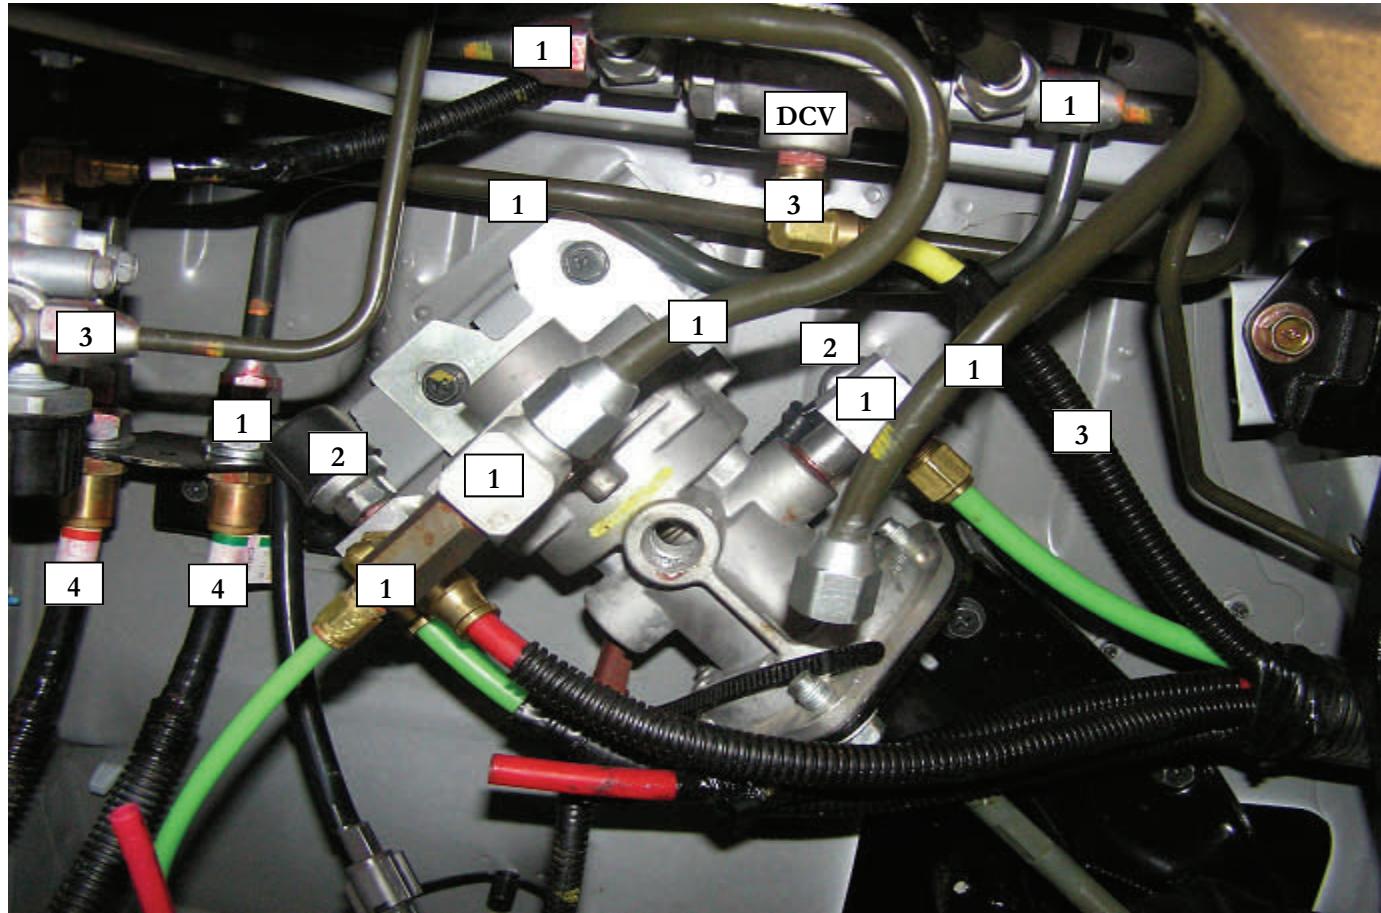
Figure B - LH Foot Valve

- 1 Remove all steel lines and fittings from the LH foot valve and discard.
- 2 Remove brake light switches and save for later use.
- 3 Do Not remove the steel line for the air seat and one fitting from the double check valve (DCV) and its air line.
- 4 Remove the main air hoses from the fittings and remove and discard the bracket.

Step 3) Remove all of the fittings, steel air lines and brake switches from the LFT side foot valve and park brake double check valve as shown in 1 ~ 4 above.

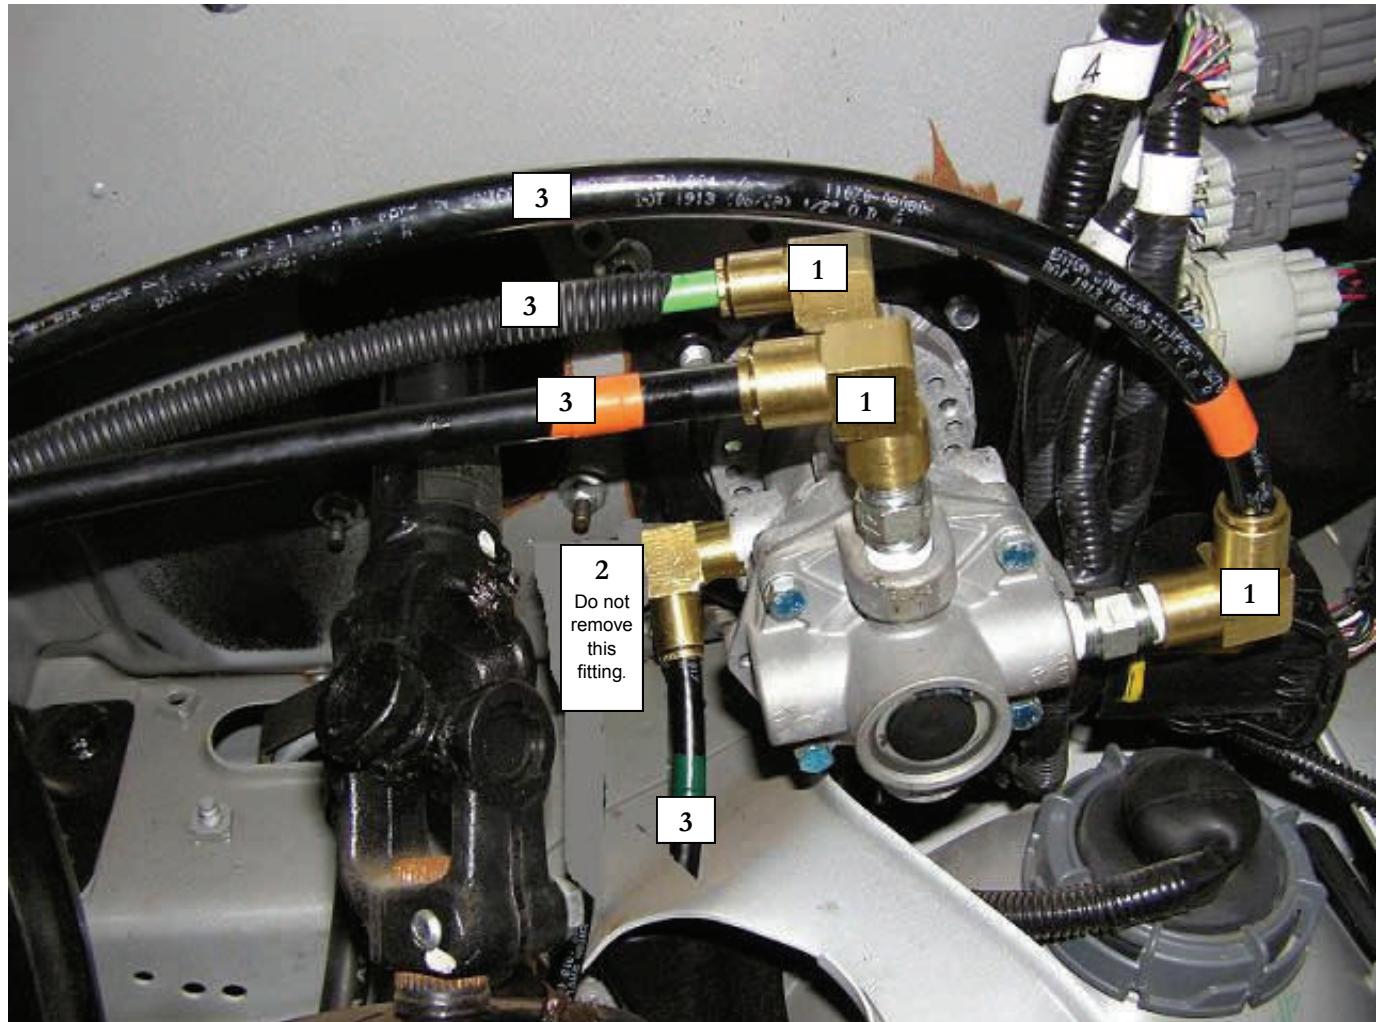
Figure C - RH Foot Valve

- 1** Remove 3 fittings from the RH foot valve.
- 2** Do Not remove the fitting closest to the steering shaft.
- 3** Remove all existing plastic air lines from the RH foot valve and discard.

Step 4) Remove 3 of the fittings and all air lines from the RT side foot valve as shown in 1 ~ 3 above.

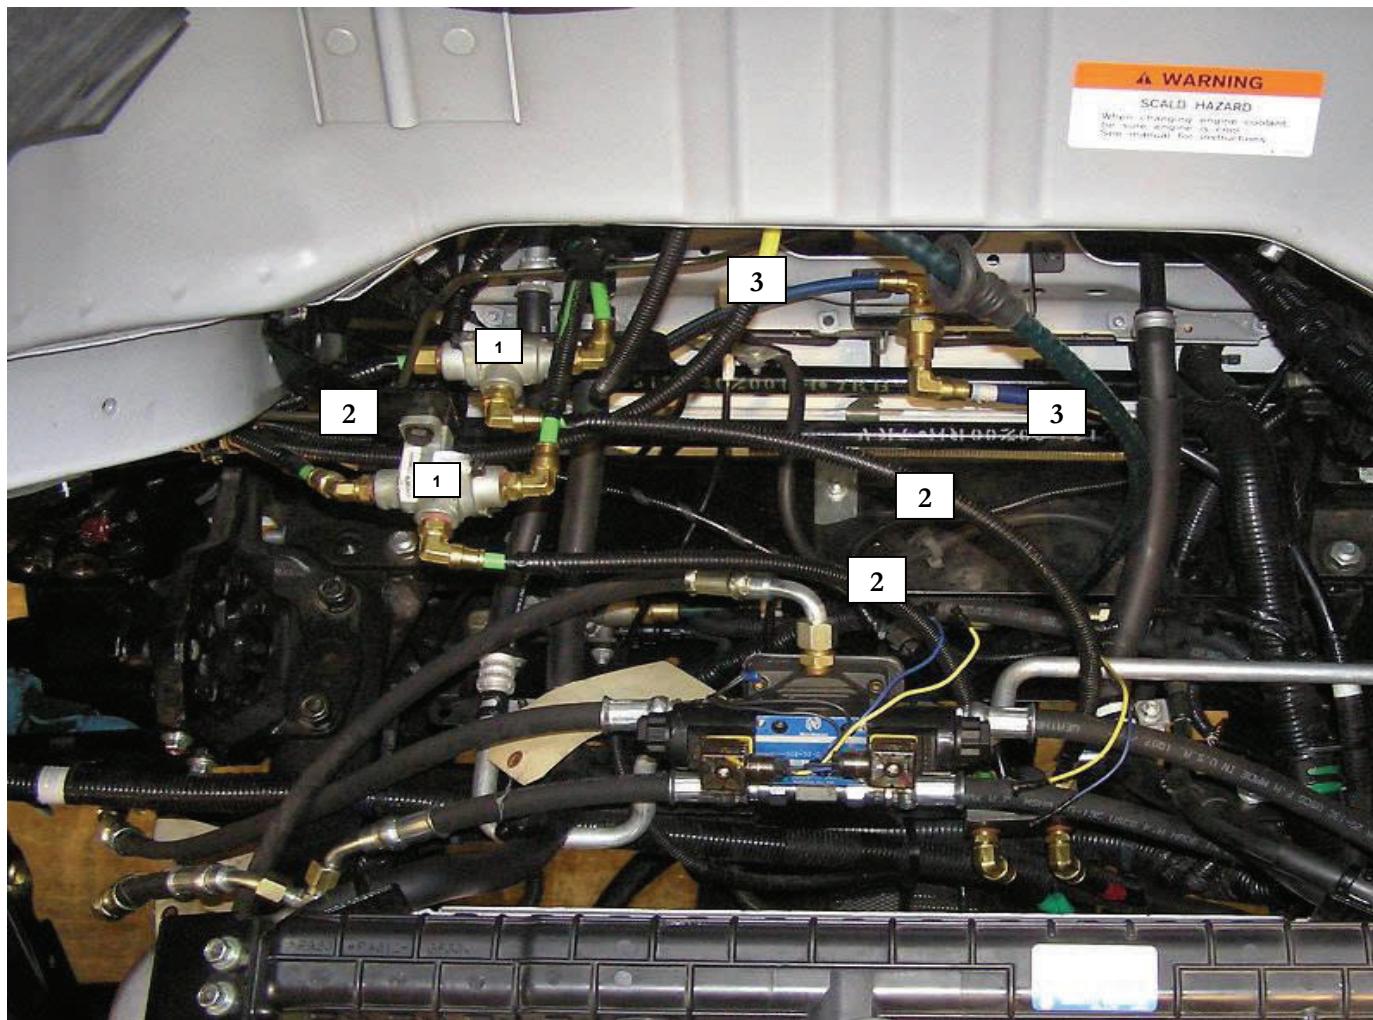
Figure D

DCV's & air lines

- [1] Remove 2 double check valves (DCV) and discard.
- [2] Remove the air lines and DCV mounting bracket and discard.
- [3] Do Not remove the air lines that enter the cab or air lines that are not connected to the DCV's.

Step 5) Remove the double check valves, mounting bracket and air lines to these valves as shown in 1 ~ 3 above.

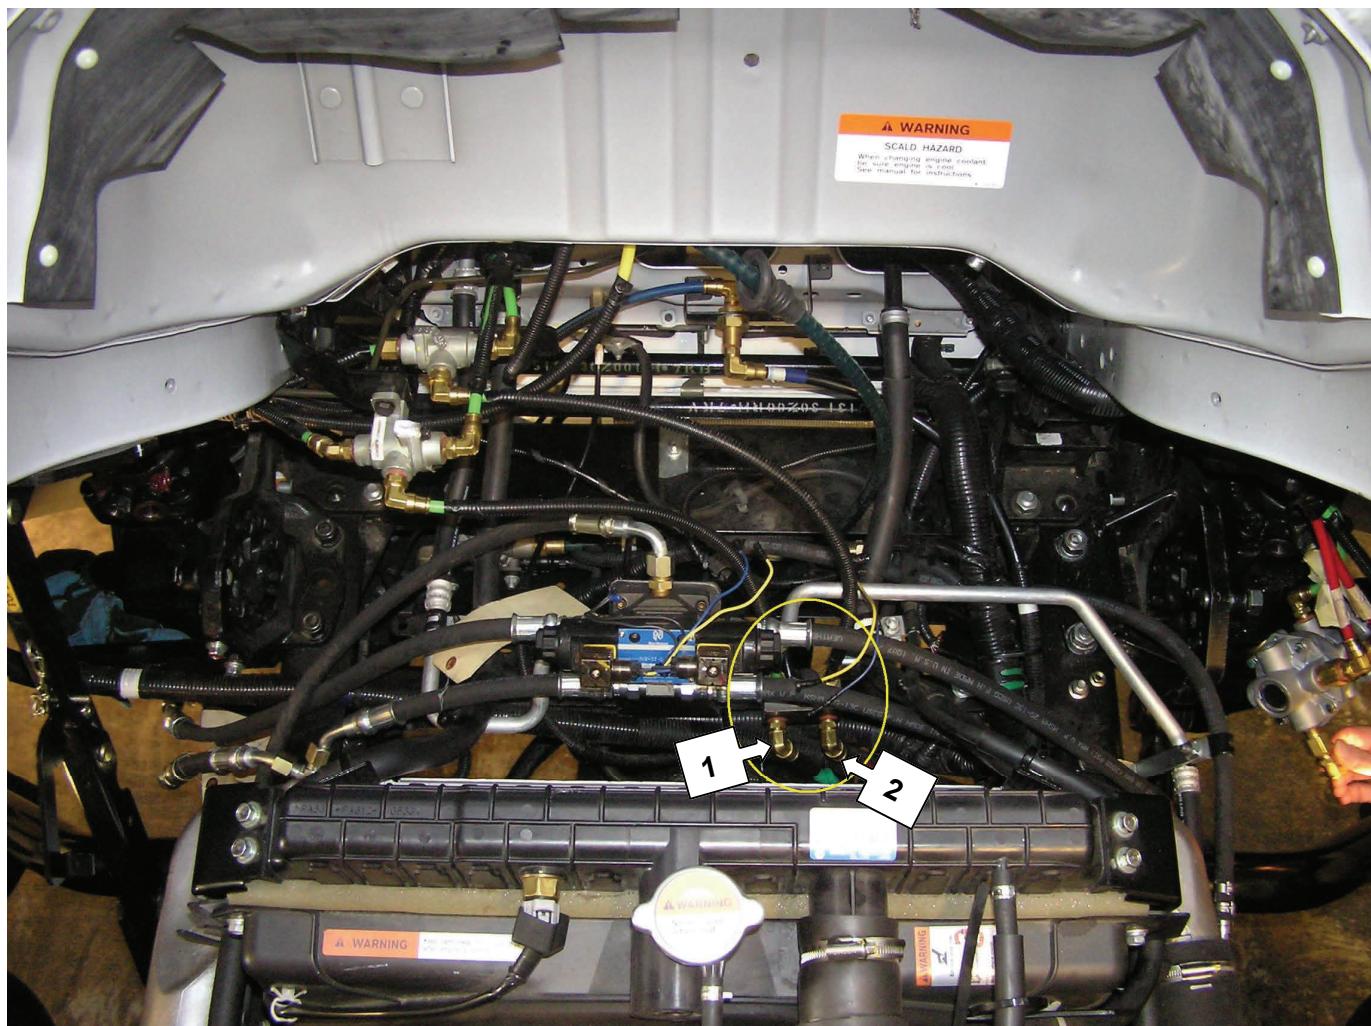
Figure E

Aluminum switch block, brake light switch & air lines

- 1** The aluminum switch block is located under the power steering hoses.

- Remove the air lines from the aluminum switch block.
 - Remove the aluminum switch block.
 - Remove the brake light switch from the switch block, save switch for reuse and discard aluminum block.
- 2** This 1/2" air line will be used to connect to the new R12 valve as shown in Figure G.

Step 6) Remove the aluminum switch block and brake light switch as shown in 1 & 2 above.

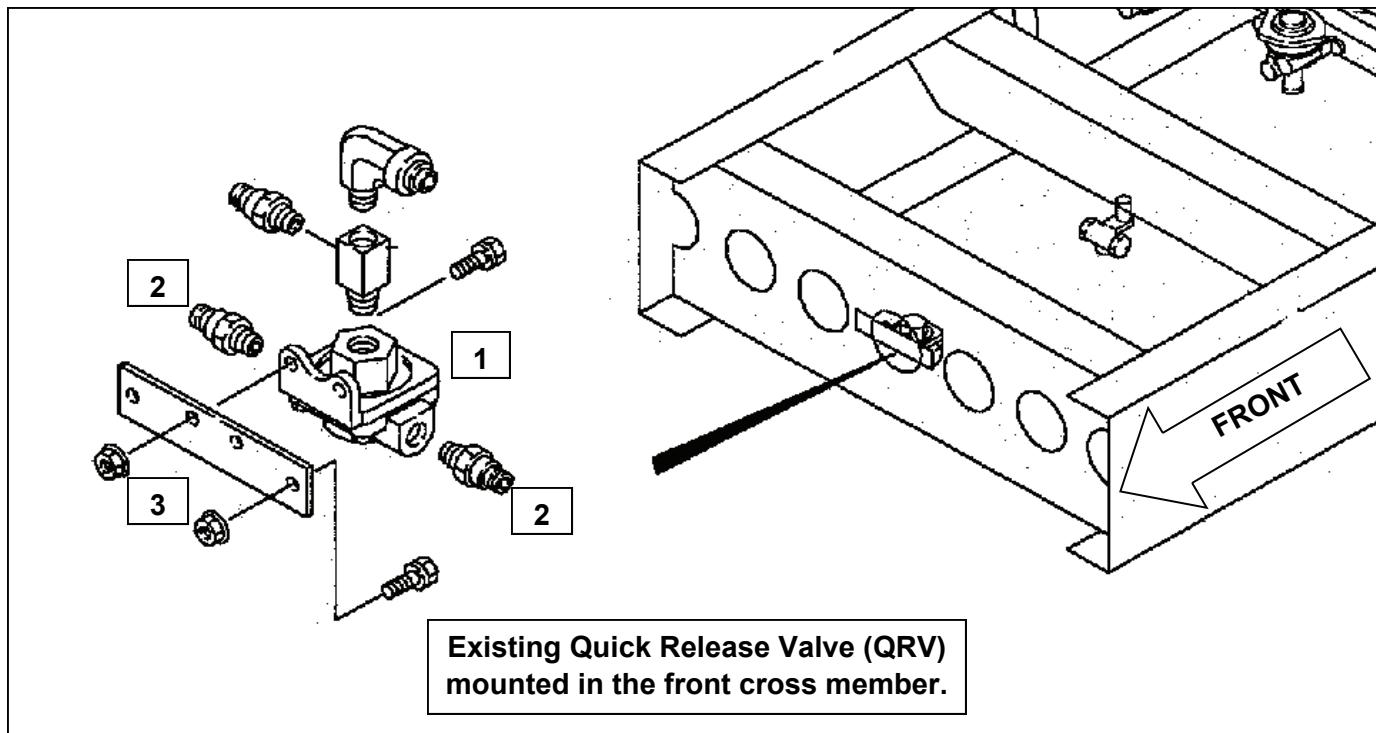
Figure F

- 1** Existing QRV mounted in the front cross member.
- 2** Carefully remove the ABS modulator air lines from the QRV. Do not remove the air lines from the modulators. The air lines will be reconnected to the new R-12 valve.
- 3** Remove the 2 bolts that attach the QRV mounting bracket to the front cross member. Remove the valve from the bracket and discard the QRV.

Step 7) Remove the Quick Release Valve (QRV) from the front cross member as shown in 1 ~ 3 above.

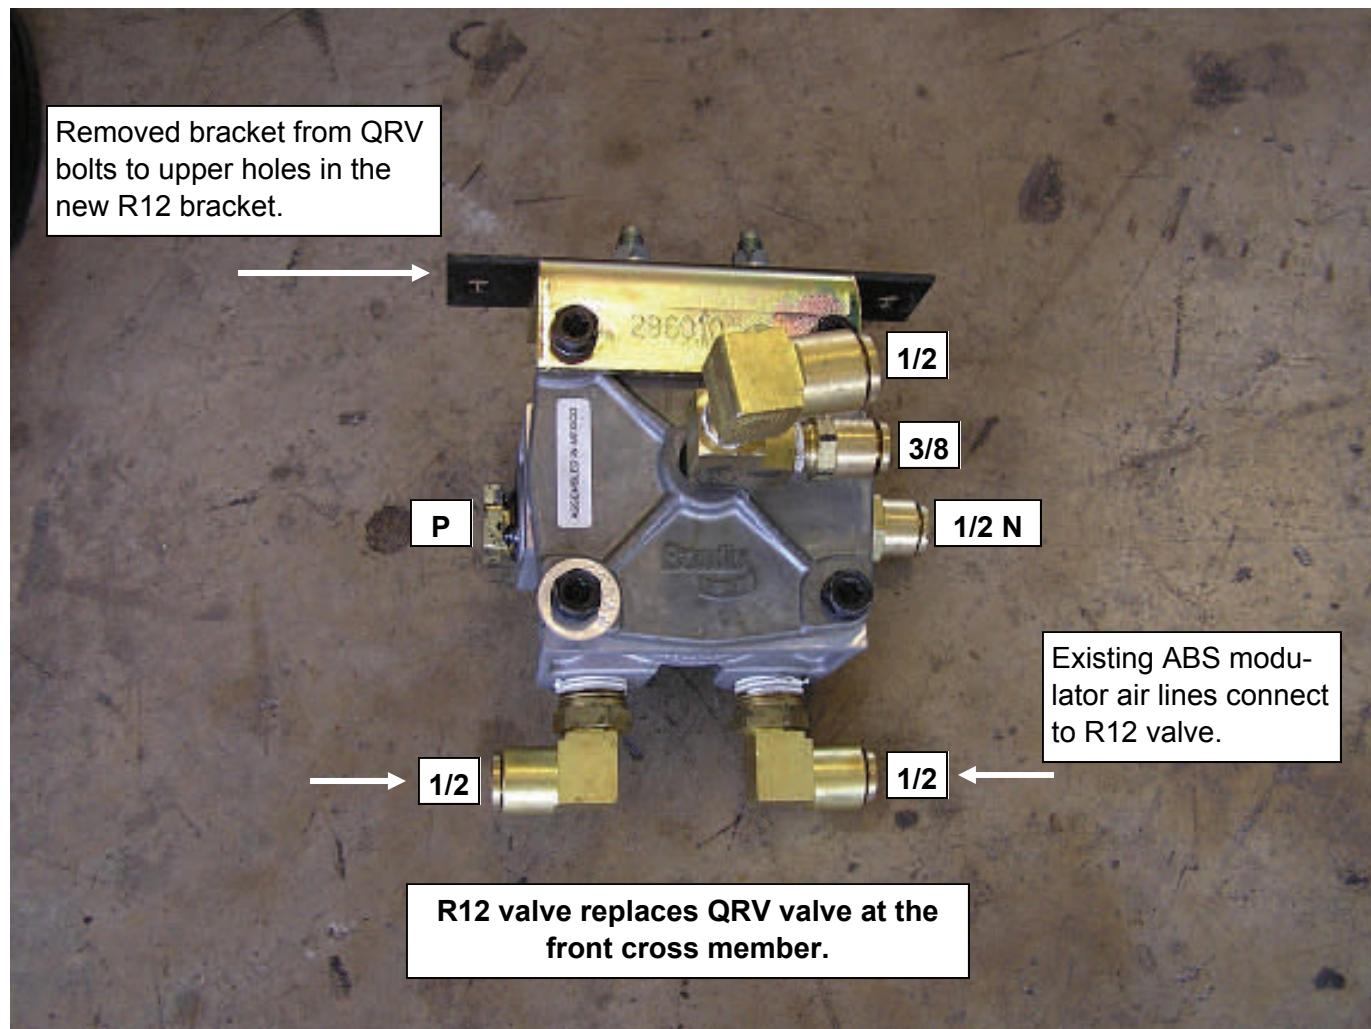
Figure G

Install the new fittings in the R12 valve as shown.

3/8 3/8" air line fitting.

1/2 1/2" air line fitting.

1/2 N A new 1/2" air supply line will be installed at this location.

P Install furnished pipe plug.

- Mount the R12 valve to the front cross member using the existing mounting bolts.
- Connect the existing ABS modulator air lines to the R12 valve.

1/2 N Connect the 1/2" air line removed from the aluminum switch block in figure E to this location.

Step 8) Assemble the new R-12 valve as shown above and install to the front cross member.

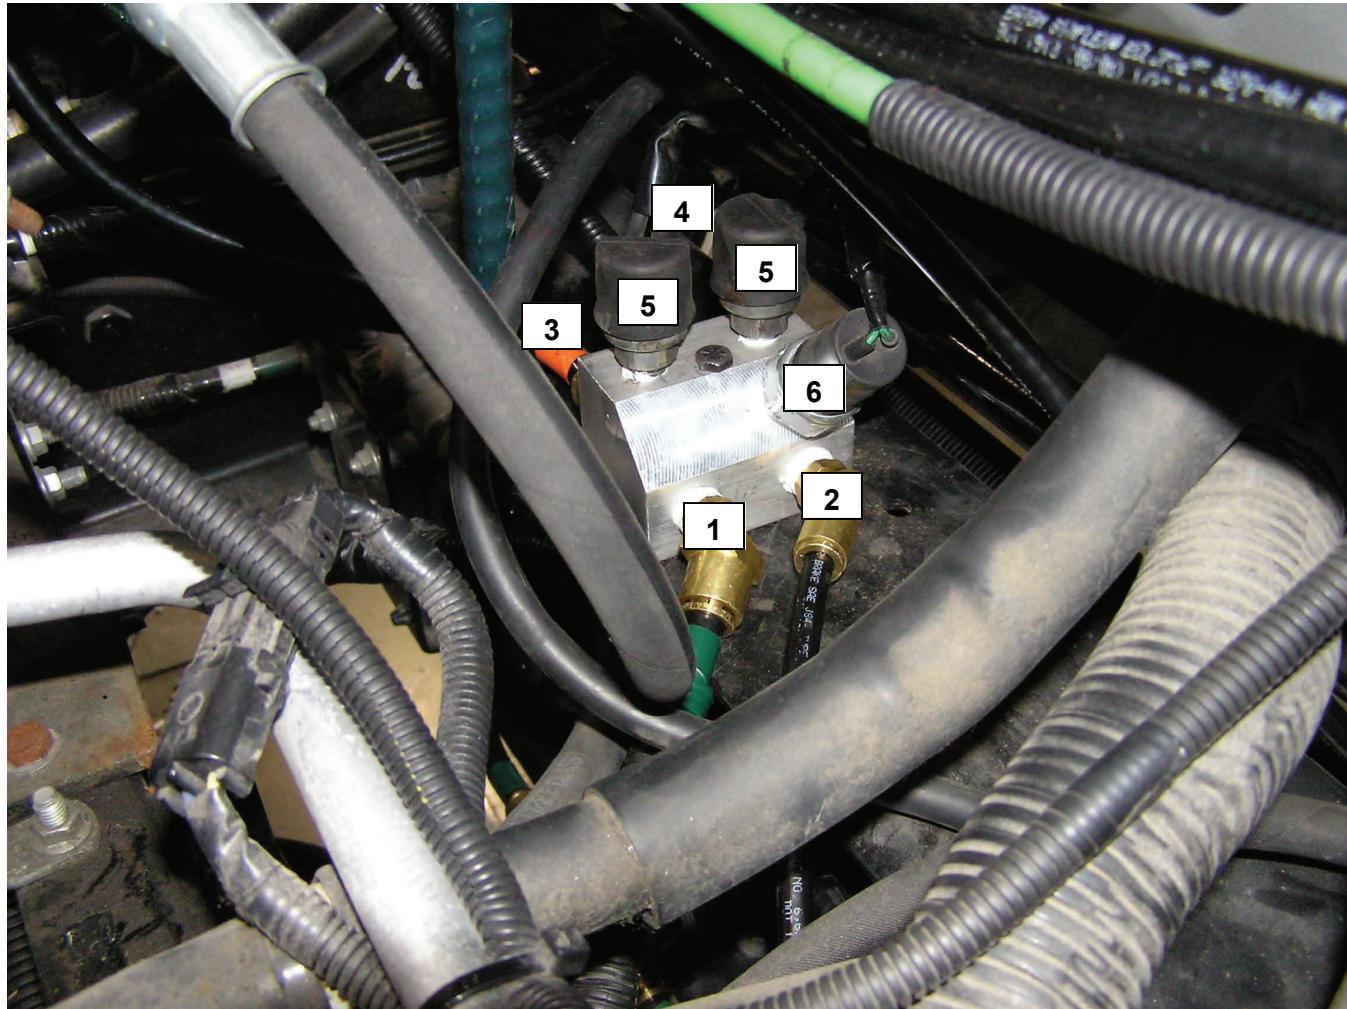
Figure H

Install the air line fittings and brake light switches in the aluminum switch block and bolt the switch block to the top of the front cross member as shown.

- [1] 45° fitting for 1/2" air line
- [2] 45° fitting for 3/8" air line
- [3] Straight fitting for 1/2" air line
- [4] Straight fitting for 3/8" air line
- [5] Brake light switch for the front and rear brakes.
- [6] Brake switch to deactivate the cruise control.

Step 9) Install the brake light switches and new fittings in the new aluminum switch block and mount as shown in 1 ~ 6 above.

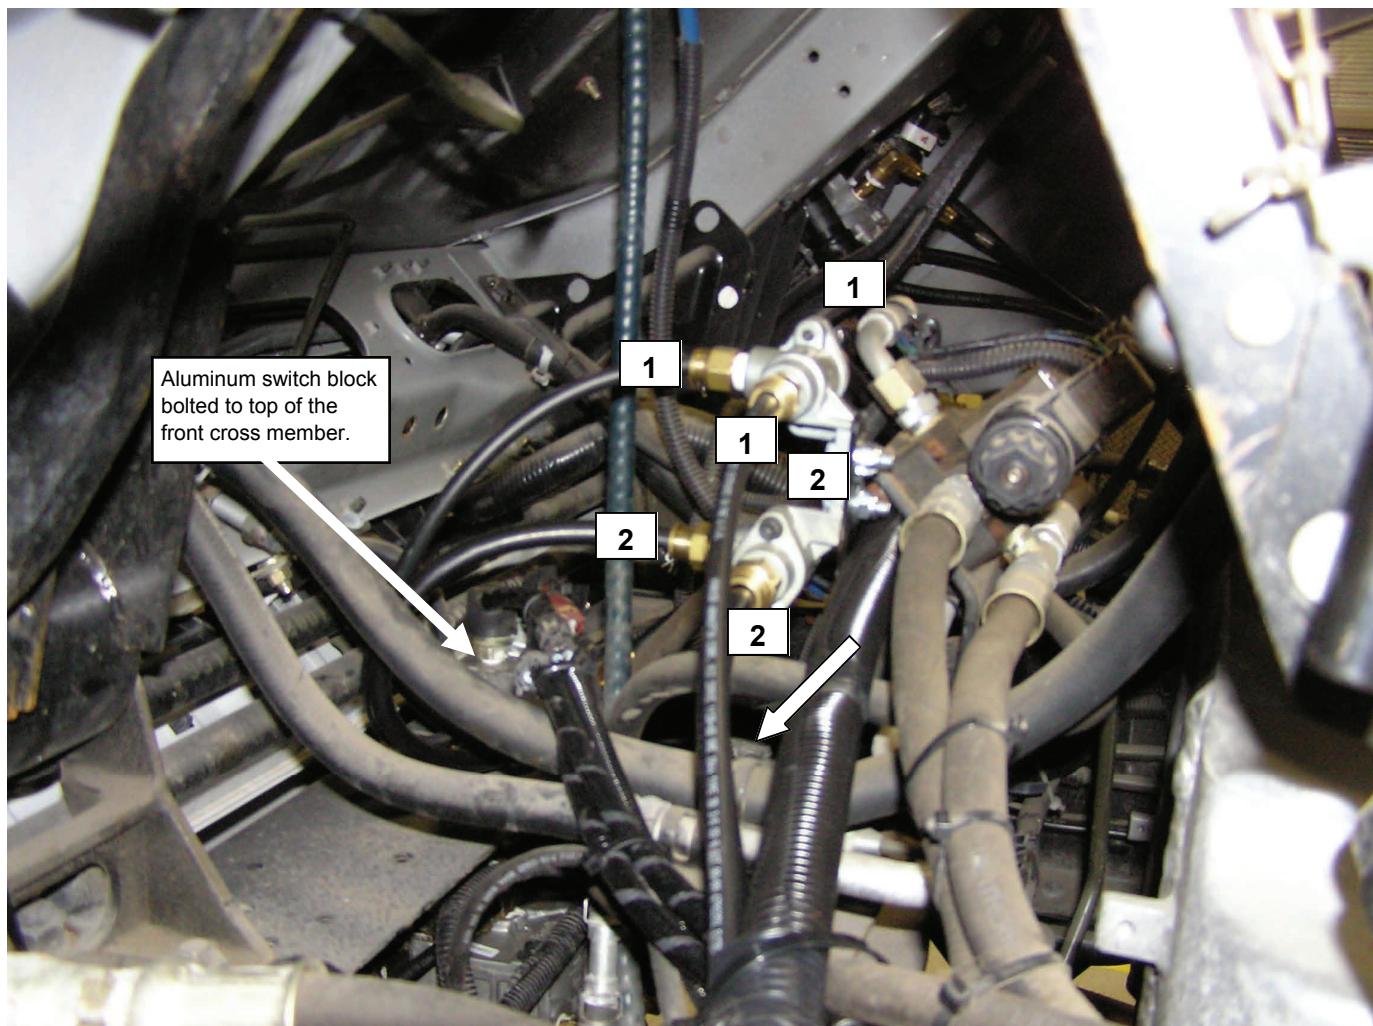
Figure I

Install the 3/8" air line fittings in one double check valve (DCV) and the 1/2" air line fittings in the other DCV. Install both DCV's to the mounting bracket and bolt the bracket to the heater hose support bracket as shown.

1 3/8" air line fittings. Install air line to the aluminum switch block straight fitting as shown.

2 1/2" air line fittings. Install air line to the aluminum switch block straight fitting as shown.

→ Remove the bolt for the heater hose bracket and attach the DCV bracket.

Step 10) Install 2 new double check valves with new fittings to the new mounting bracket as shown above.

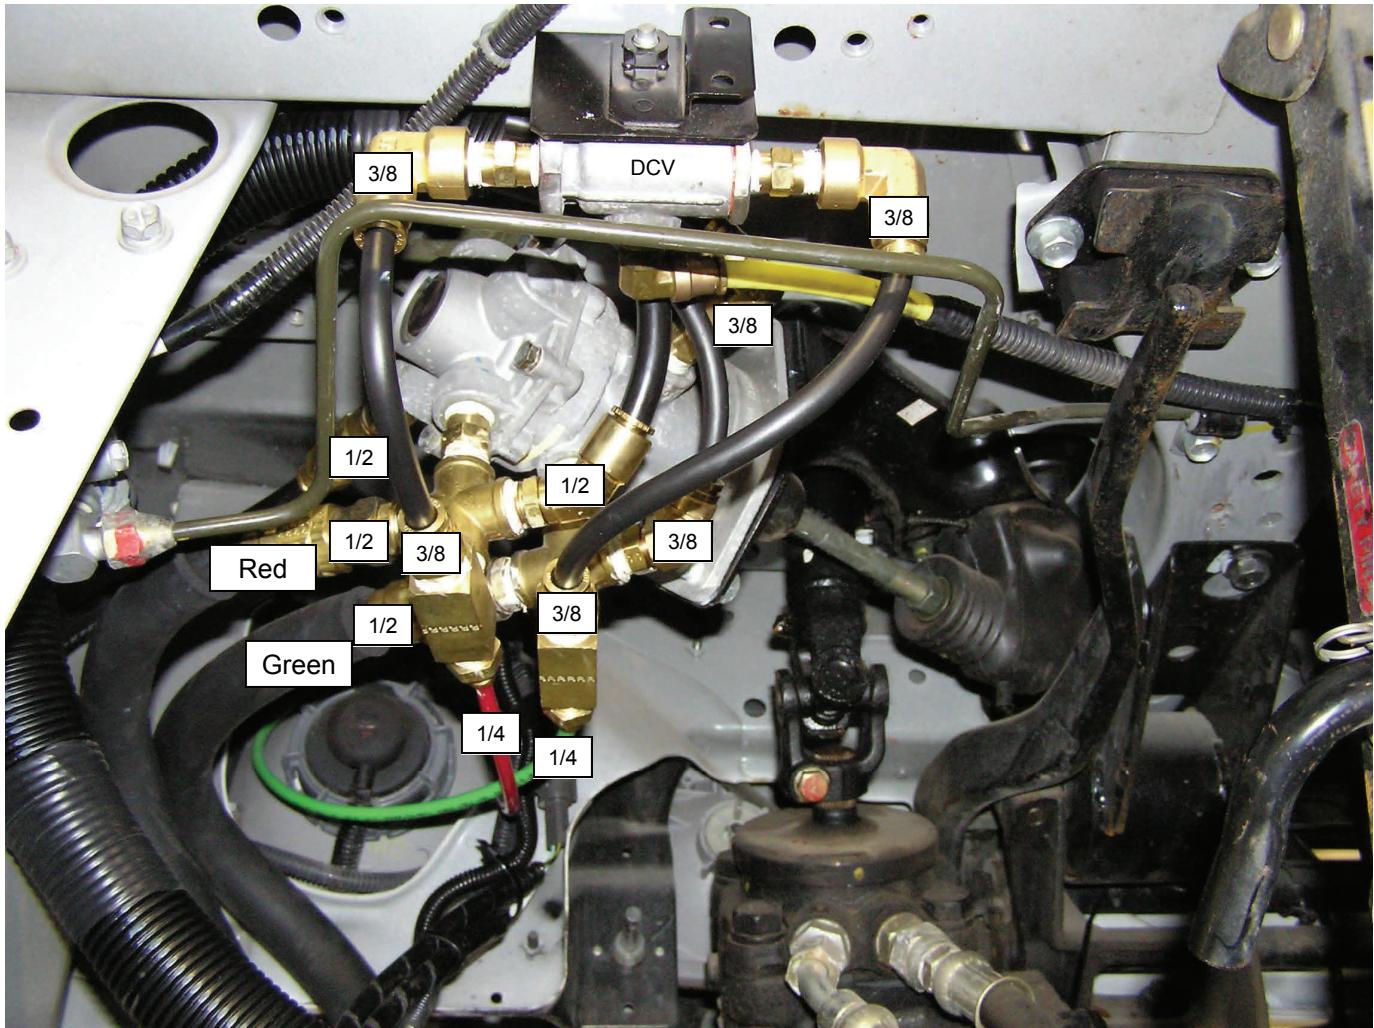
Figure J

LH foot valve with new air lines and fittings installed.

CAUTION: The pipe thread adapter fittings are BSPT on one end and NPT on the other end. BSPT is installed into the foot valves and existing park brake DCV.

CAUTION: "T" fittings must be installed as shown to prevent contact when the cab is lowered. After installation verify "No Interference" with cab down.

3/8 3/8" air line fittings.

1/2 1/2" air line fittings.

1/4 1/4" air line fittings.

Green 1/2" Factory air supply line with green stripe. Also see figure B, number 4.

Red 1/2" Factory air supply line with red stripe. Also see figure B, number 4.

Step 11) Install the new fittings in the LFT foot valve and park brake DCV as shown above.

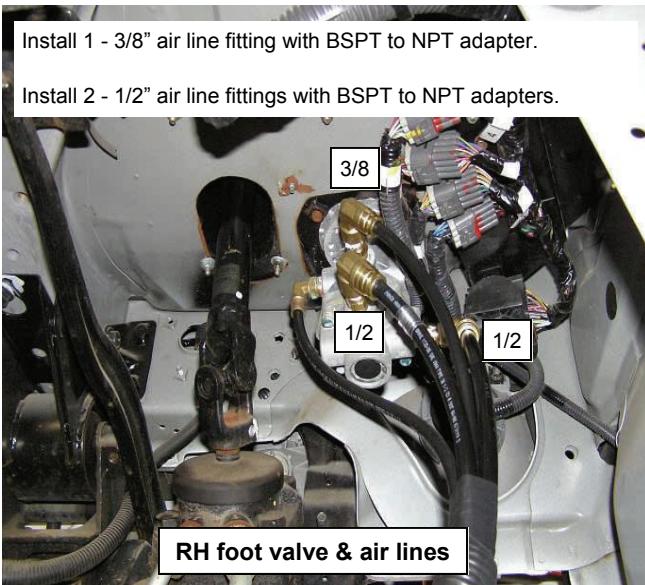
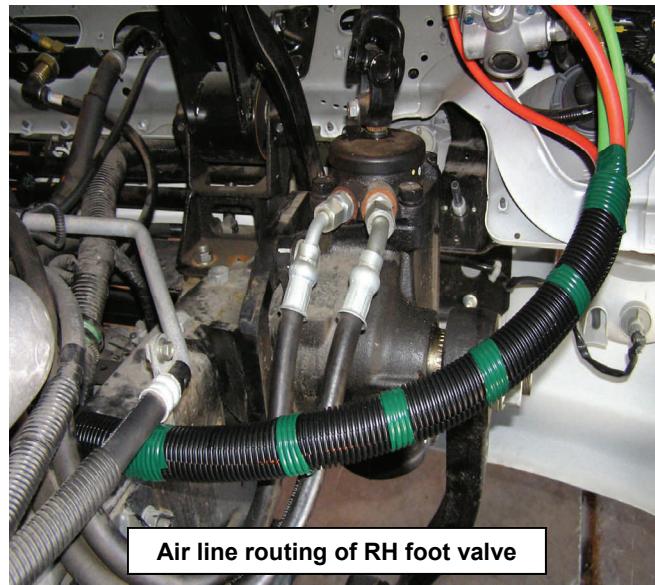
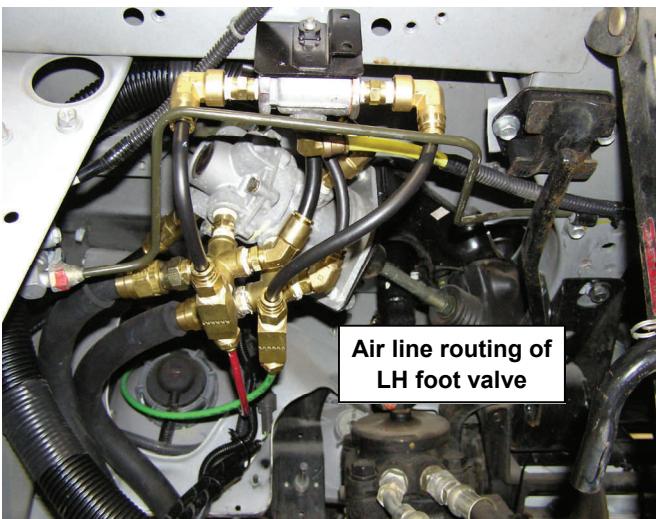
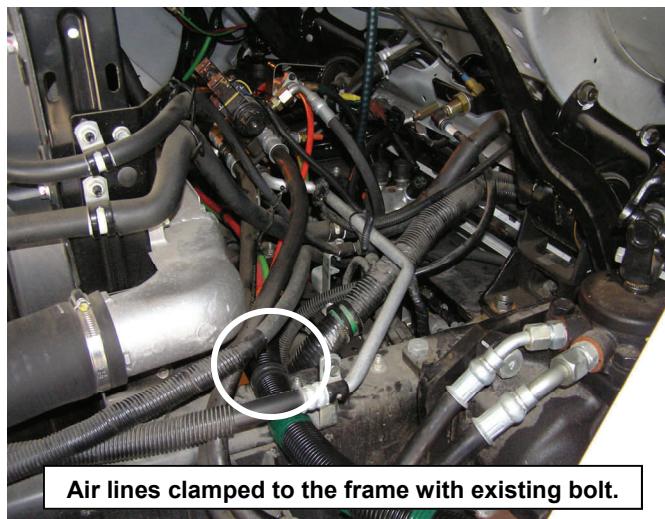
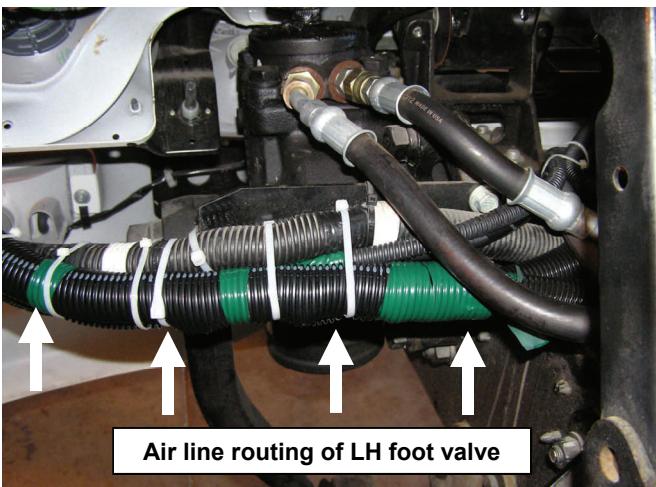
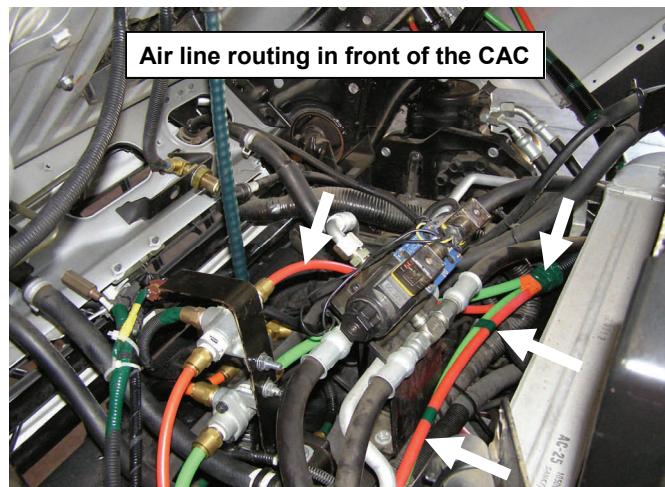
Figure K

Step 12) Install new fittings in the RT foot valve as shown in the top left photo.

Step 13) Using the photos in figure K and air line diagram figure L, Install new air lines between the LFT and RT foot valves and double check valves.

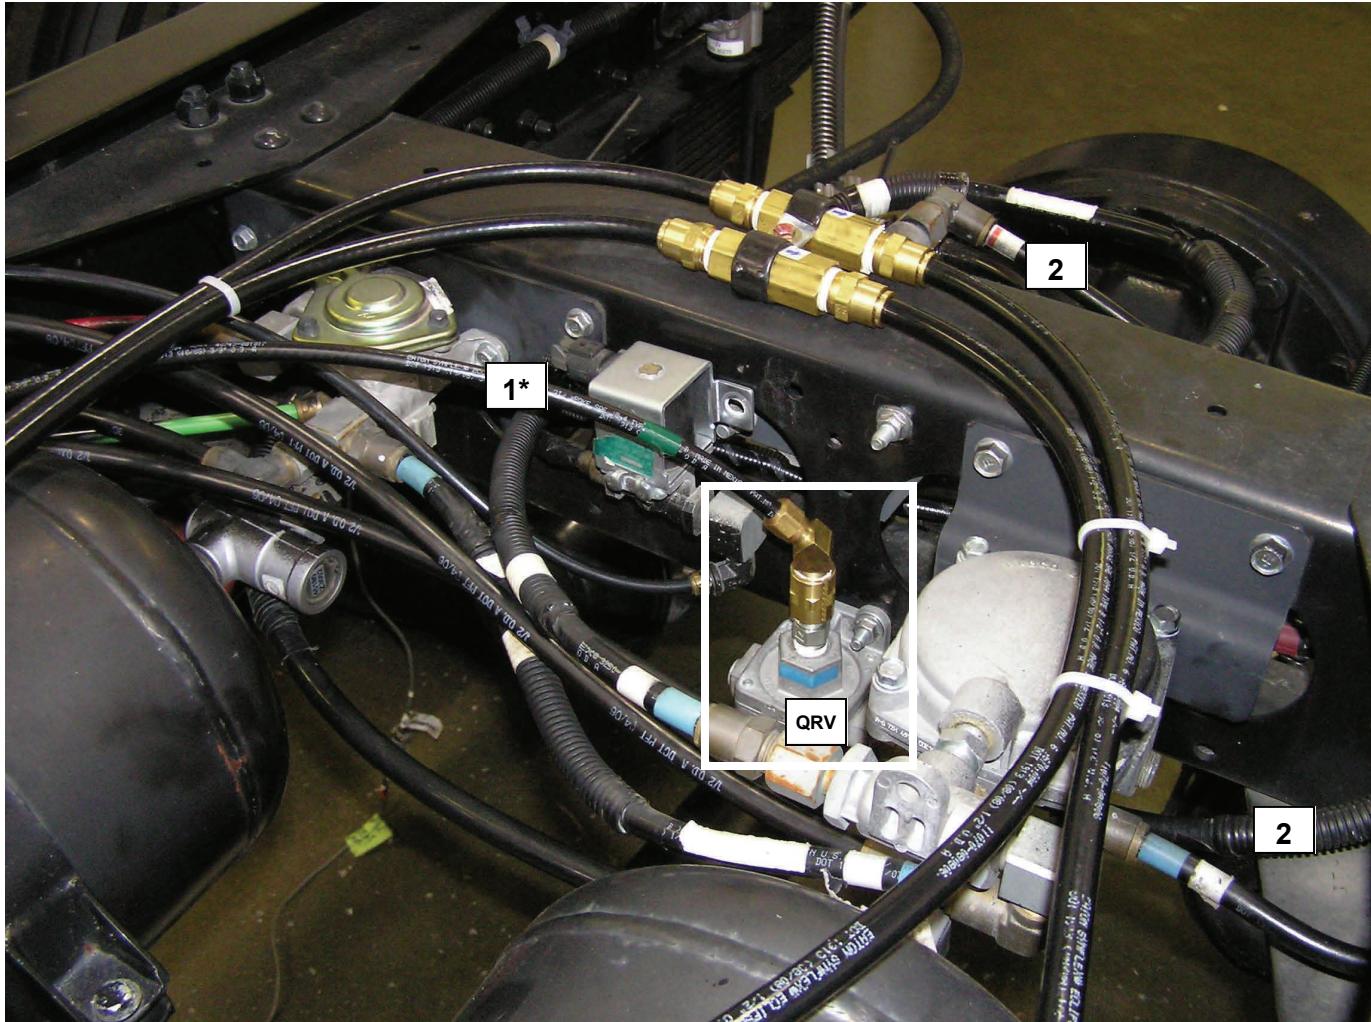
Figure M

1* Disconnect the 1/2" air line from the rear brake QRV inlet.
NOTE: The 1/2" air line will be used in step 16, figure O.

2 Remove the 1/2" air line from the QRV outlet to the relay valve mounted on the rear side of the cross member.

Unbolt the QRV from the cross member, change the air line fittings for 3/8" air line and bolt the QRV inside the RT frame rail near the rear engine mount as shown in **figure N**.

(NOTE) 1* Connect the front end of this 1/2" air line to the (1/2 N) fitting located on the R-12 valve as in **figure G**.

Step 14) Disconnect the 1/2" air lines 1 & 2 from the rear brake QRV and relocate the valve as shown in figure N.

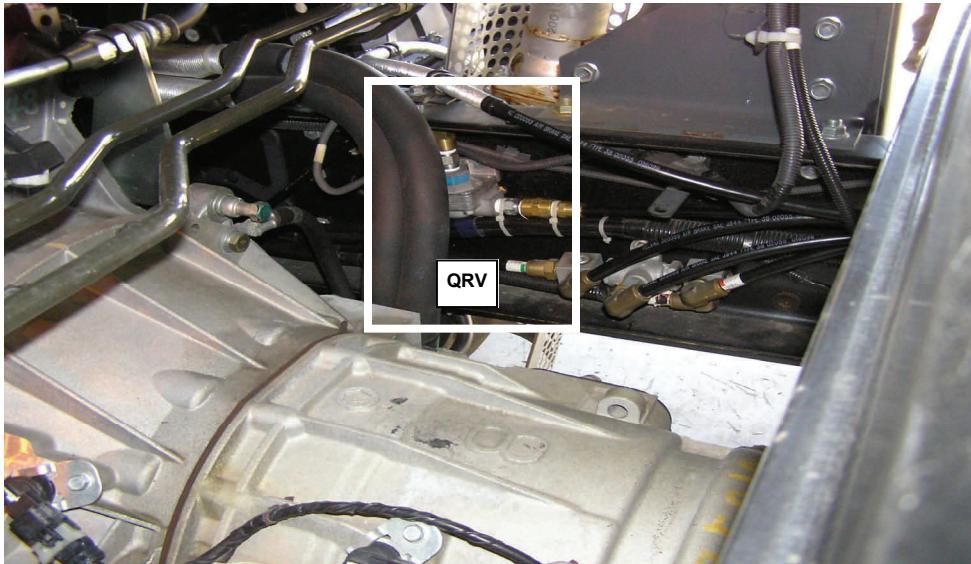
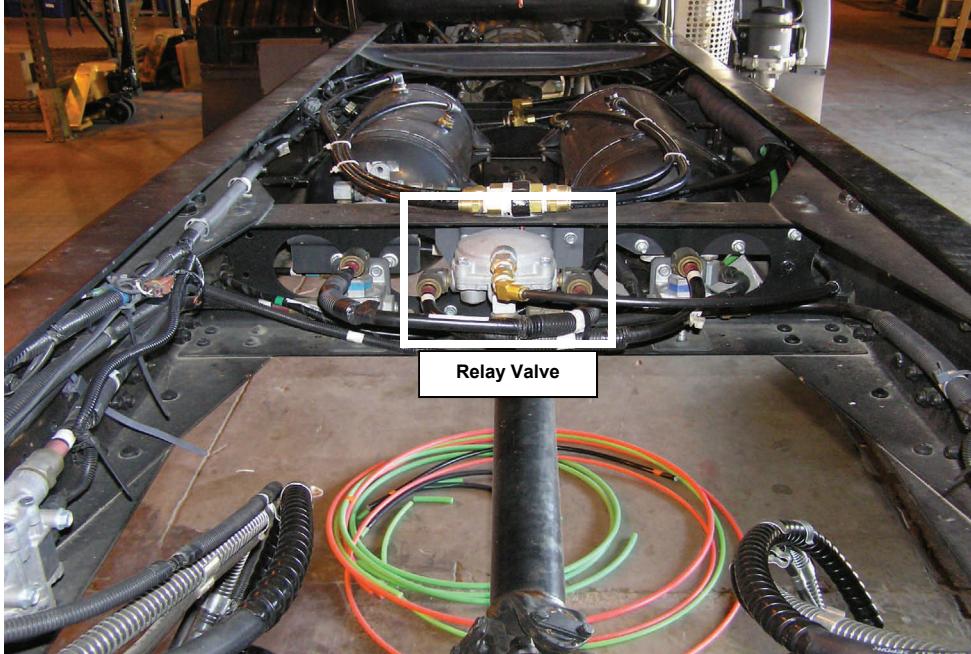
Figure N

QRV Relocated rear brake QRV inside the RT frame rail. Install new 90° 3/8" air inlet fitting and straight 3/8" outlet fitting. The QRV bolts to the frame with one attaching bolt in existing hole. Install a new 3/8" air line from the aluminum switch block to the QRV. See figure H, item 2.

Relay Valve Replace the 1/2" air line fitting with a 45° 3/8" fitting. Install a new 3/8" air line from the QRV outlet to the relay valve.

Step 15) Unbolt the QRV from the rear suspension cross member, change the 1/2" air line fittings to 3/8" air line and relocate the QRV to the inside of the RT frame rail near the rear engine mount as shown above.

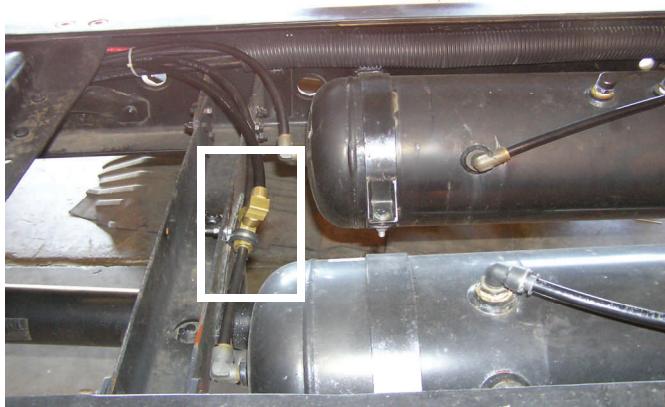
Air line splice

1. Install the 1/2" air line splice and clamp it to the cross member as shown.
2. Connect the 1/2" air line (removed from the QRV valve in **Step 14, figure M**) to the splice.

Step 16)

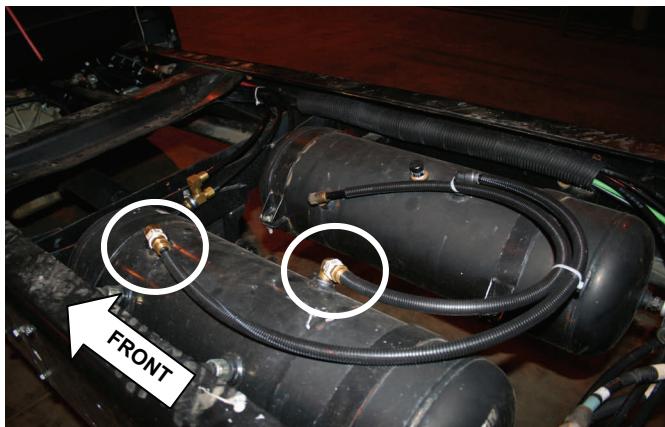
Air tank check valves

1. Install 2 -1/2" check valves in the double chamber air tank.
2. Connect the air lines to the check valves.

Step 17)

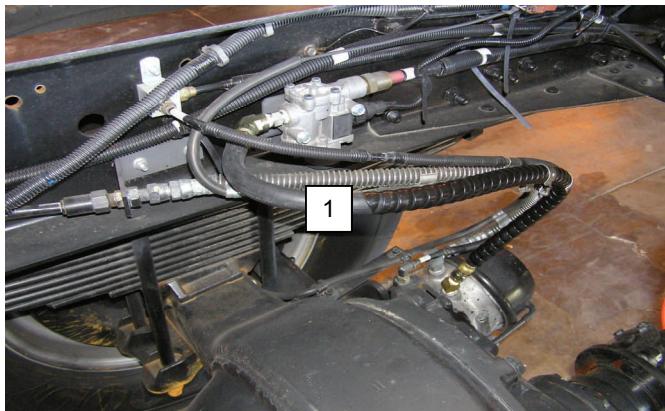
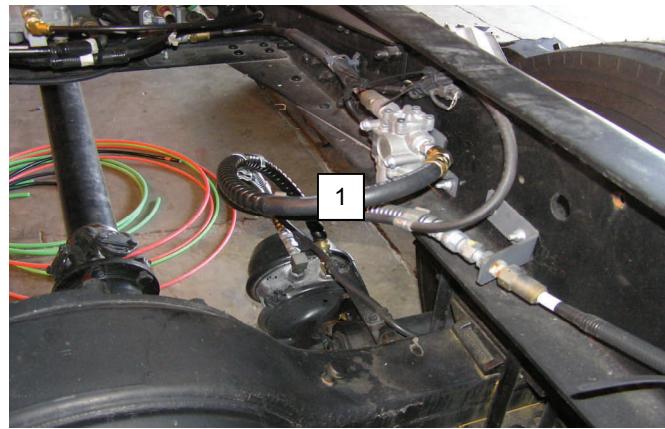
Figure O

Installation of new rear service brake hoses from the ABS modulators to the chambers using 45° fittings on both ends as shown.

NOTE: The hose swivel end attaches to the chamber.

1. Starting at the hose swivel end, wrap the hoses with the spiral hose wrap prior to installation.
2. Install one 45° fitting with a BSPT adapter in the ABS modulator and one 45° fitting with no adapter into the chamber.
3. Clamp hose to the parking brake hose with the existing clamps positioned over the spiral wrap.

Step 18)

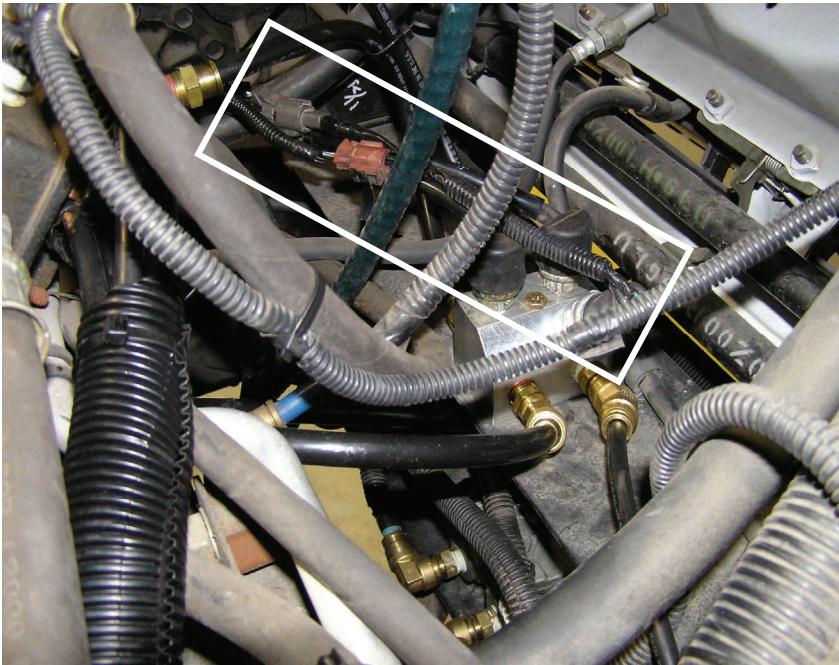
Figure P

1. Install 2 new harnesses p/n-2402733209 to the brake light switches.
2. Cut the cruise switch harness on the cab side and splice in sufficient wire to connect the harness to the switch. Use heat shrink to seal connections.

Brake light switch wiring

Step 19)

Step 20) Lower the cab and verify the fittings on the LH foot valve and all air lines are free of interference. Run the engine and build up the air pressure. Release the parking brake. Check the brake operation from both sides and verify the brake lights operate and no air leaks.
