RECALL BULLETIN 05V-262 (Rev. A)

DATE: OCTOBER 7, 2005
 MODEL YEAR: 1999 thru Early Production 2002
 CHASSIS MODEL: UD1200/UD1400
 BULLETIN NUMBER: SC-262
FILE IN THE ELECTRICAL SECTION OF THE TECHNICAL BULLETIN BINDER
 (Discard previous Recall Bulletin dated September 12, 2005)

**VOLUNTARY SAFETY RECALL CAMPAIGN NUMBER 05V-262:
 BATTERY CABLE INSPECTION AND/OR REPLACEMENT**

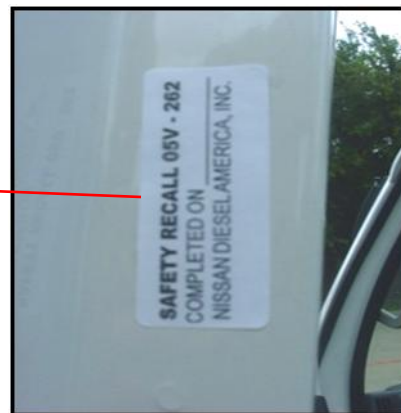
Figure A

- If the involved vehicle has a label on the inside of the driver's door as shown in Figure A, the recall has already been performed and no further action is required.
- If the involved vehicle does not have the label on the inside of the driver's door, verify through the Vehicle Service Notification screen of the NDANET2 system that the recall is required. Complete the safety recall according to the following instructions.
