SERVICE NEWS LETTER 057

ABS MODULATOR/RELAY CONNECTIONS

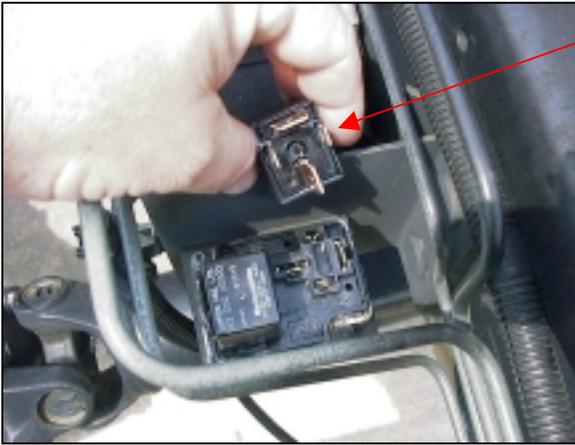
MOTOR RELAY

3. Visually inspect the modulator valve and motor relay terminal contact surfaces for any indication of poor electrical contact or broken terminals.

5. Inspect the cleaned electrical terminals for damage. If damage is present, replace the modulator valve and motor relay assembly with Genuine UD Part Number 47670-30Z00.
